Joint Danube Survey 4

Recording and assessment of hydromorphological changes 2013 - 2019

Ulrich Schwarz

Date: 21.09.2020

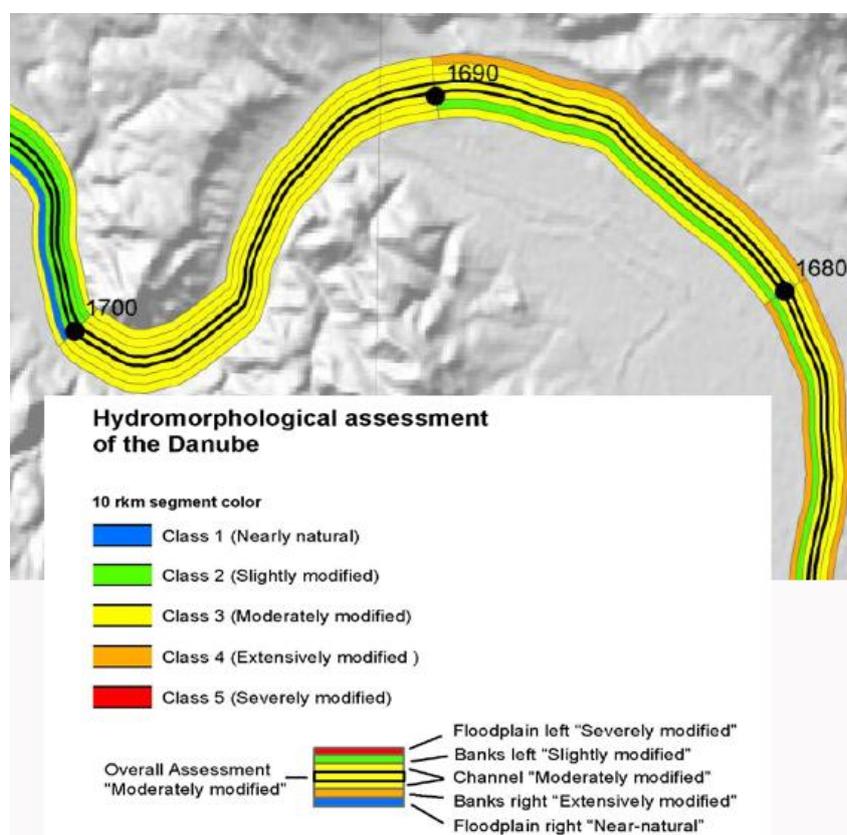
Figure 1: 10-rkm assessment segments of the JDS3 as base for JDS4 (Schwarz 2014).

For the JDS HYMO assessment 2013 the Danube was divided into 10-rkm-segments assessing channel, banks and floodplains individually before generating the overall assessment for each segment (compare figure 1 and chapter 1.2). The usage of the segmentation of JDS3 was mainly a technical step to precisely locate changes – deteriorations and improvements – and does not interfere with the definition of river section types as required to define the reference conditions for the assessment according to CEN standard. For JDS4 it was decided to update the HYMO parameters based on the same segments and to shift the assessment only to those segments with significant changes.

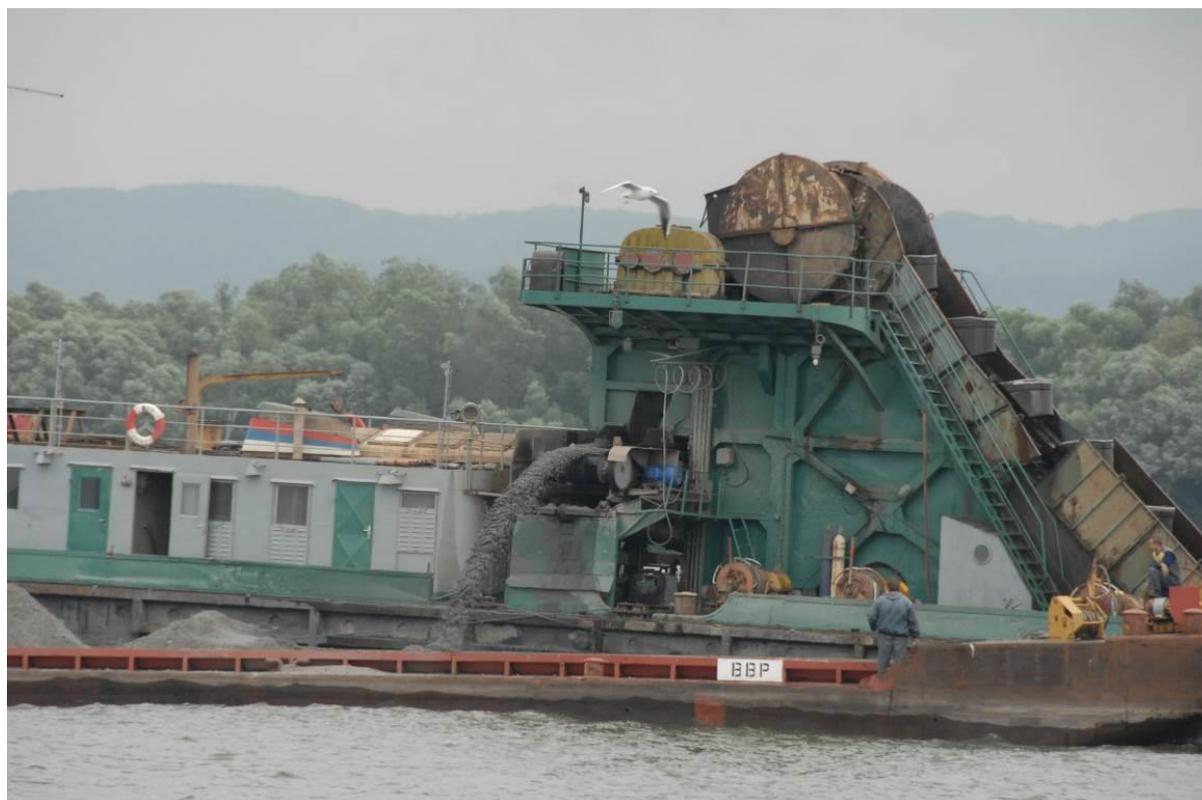
Figure 7: Particular dredging activities exceeding regular maintenance dredging affecting > 500 m reaches should be recorded (photo credit: Wolfgang Kraier).

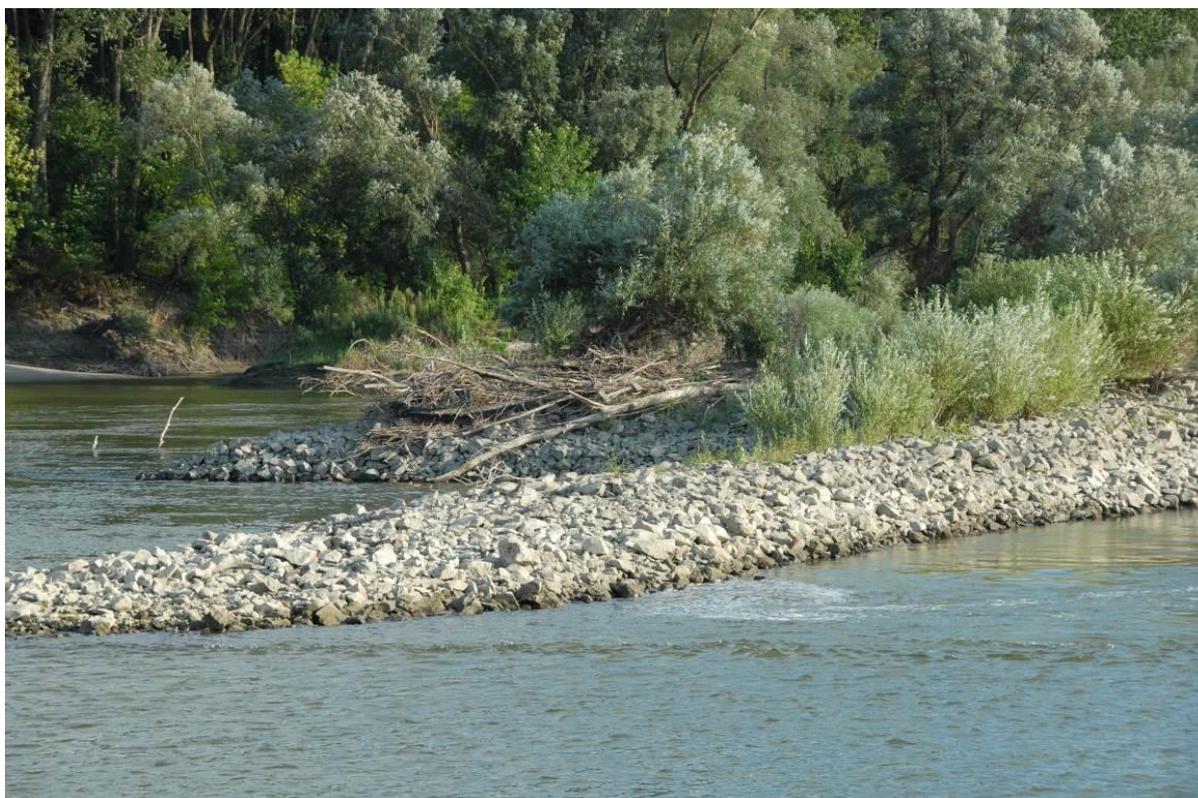
Figure 8: New established or enlarged groynes influencing flow conditions > 500 m reaches (also groin fields, guiding walls or new chevrons should be recorded (photo credit: Wolfgang Kraier).

Transversal regulation works should serve for the river regulation and the low water concentration for navigation, but also as dams for hydropower generation and navigation. In most cases, those structures are groynes (Figure 8), ground sills, ramps and even dams. Aside of the drastically changes of flow conditions in impoundments (down to stagnant conditions) also groynes or ground sills can significantly change the general and local flow conditions. The disturbance within groin fields impact the shallow water reaches influencing young fish populations.

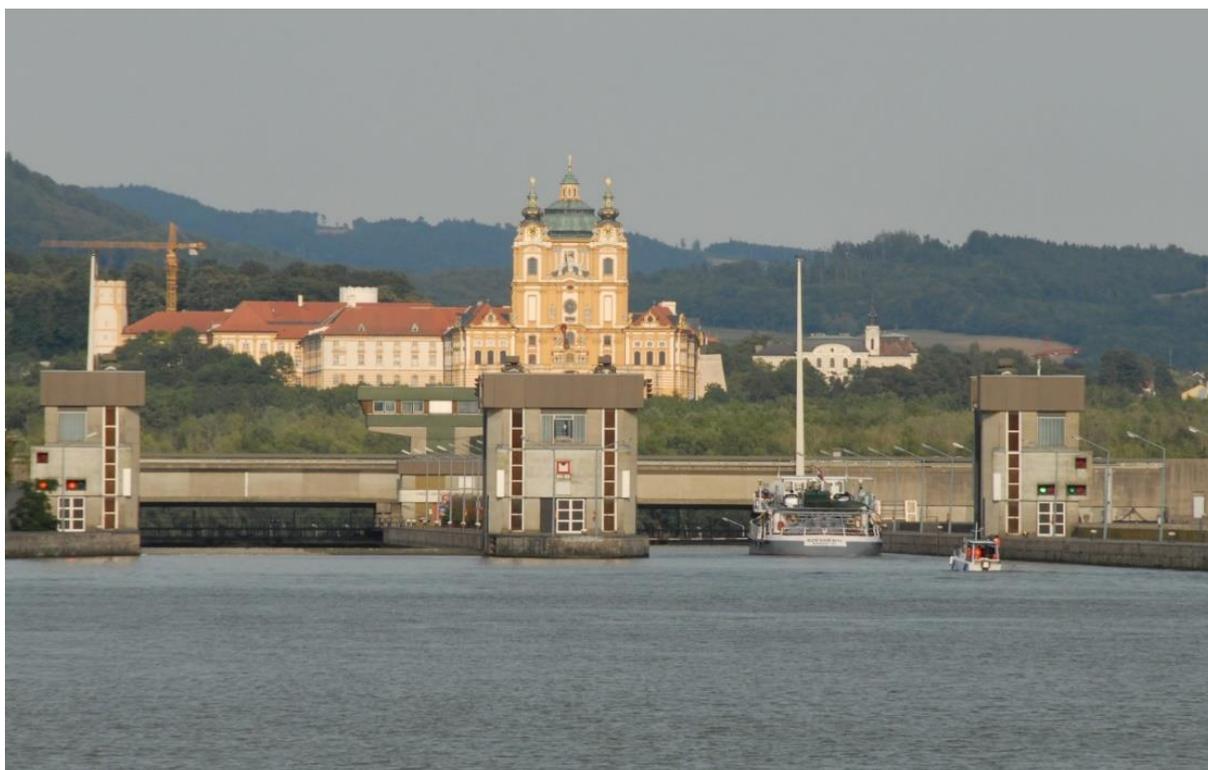
Figure 9: The hydropower dam at Melk in Austria is already equipped with a fish bypass (photo credit: Wolfgang Kraier).

There are no new dams built in Danube between 2013 and 2019. Therefore, only the restoration of fish passability is important (Figure 9). The continuum interruption for sediments was part of the DanubeSediment project. Significant changes of dam operation to improve sediment continuity or by feeding material downstream of dams should be recorded for the project period.

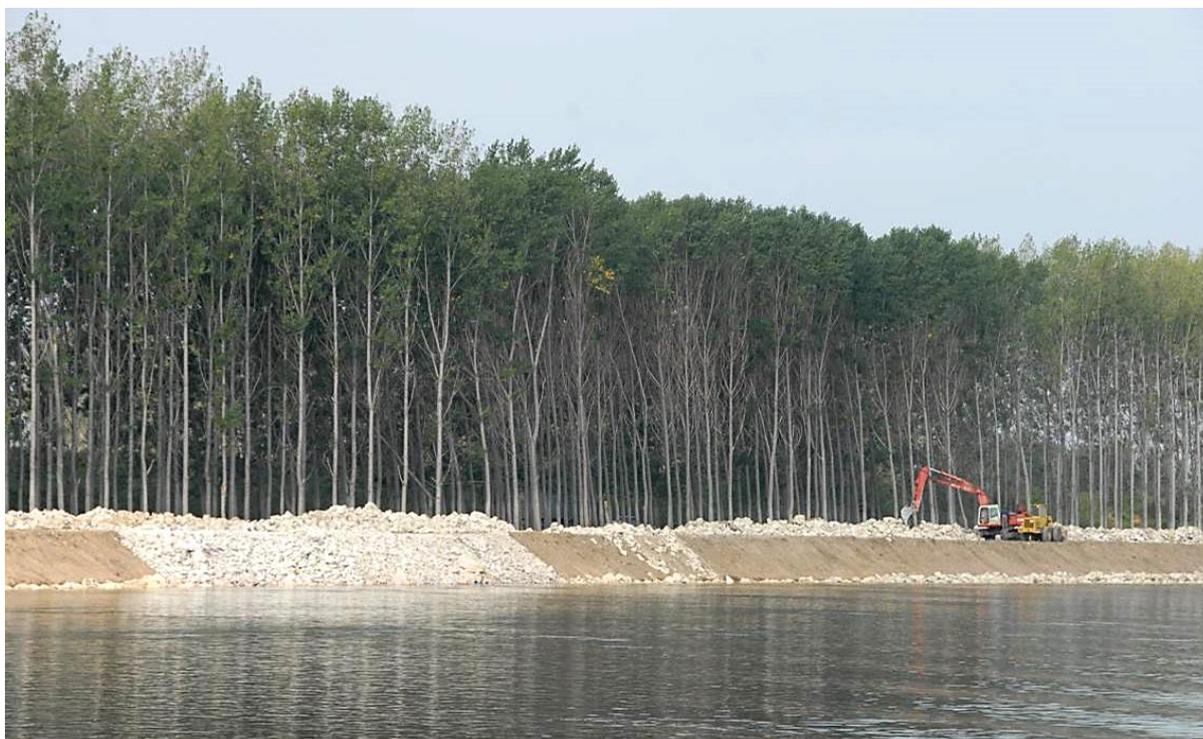
Figure 10: New or reinforced bank reaches > 500 m length should be reported (photo credit: Wolfgang Kraier).

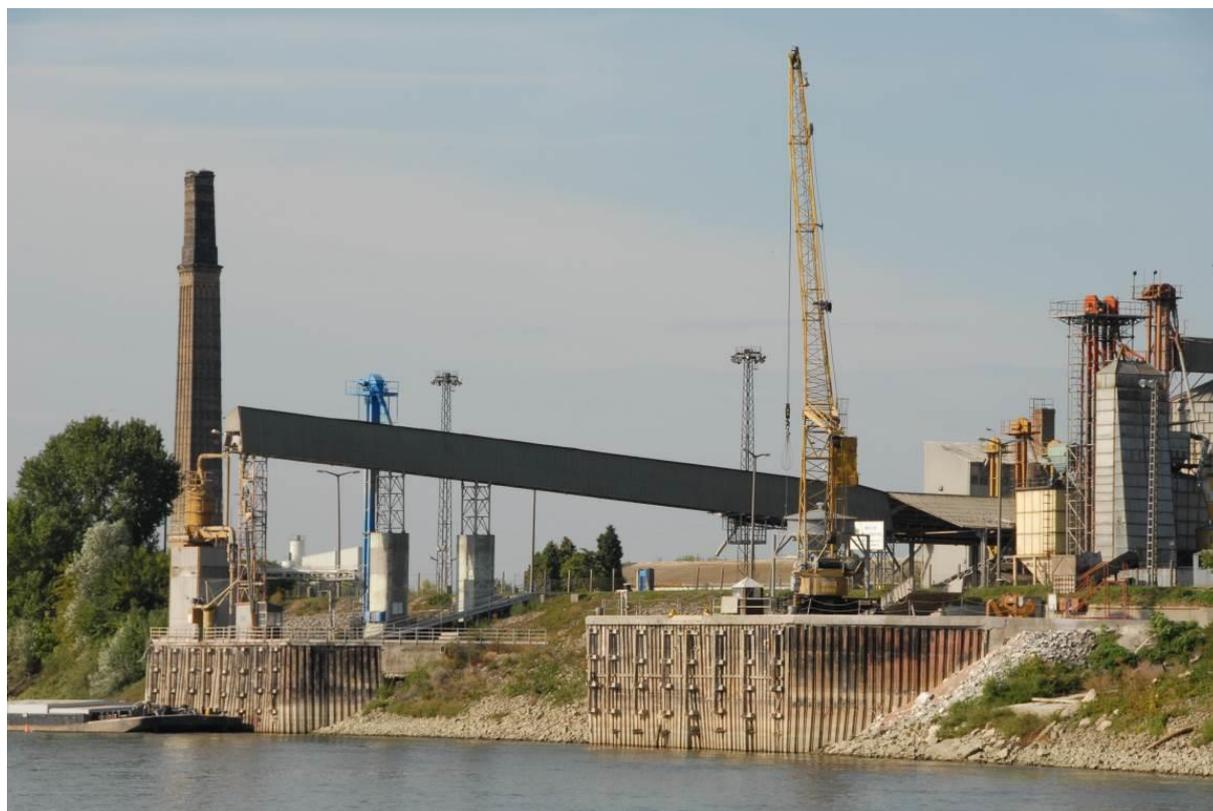
Figure 11: Completely modified riparian zone > 500 m (photo credit: Wolfgang Kraier).

The removal or change of bank vegetation is frequent where roads, infrastructure or harbours (Figure 11) have been built. The “riparian zone” in the JDS assessment comprises only the narrow strip of land on top of the river banks and is not covering the floodplain, which is a separate parameter. The changes must be long-lasting, e.g. if vegetation is cleared only temporarily to construct a new groin, the change is not to be recorded. In particular, macrophytes and helophytes living on the edge of young shallow bars and banks are affected, but also pioneer and young softwood stands, which are not assessed in respect of the WFD (EC 2000). In smaller side-channels the shadow of the bank vegetation can influence the water temperature, tree roots and woody debris origin from riparian zone influencing the aquatic life.

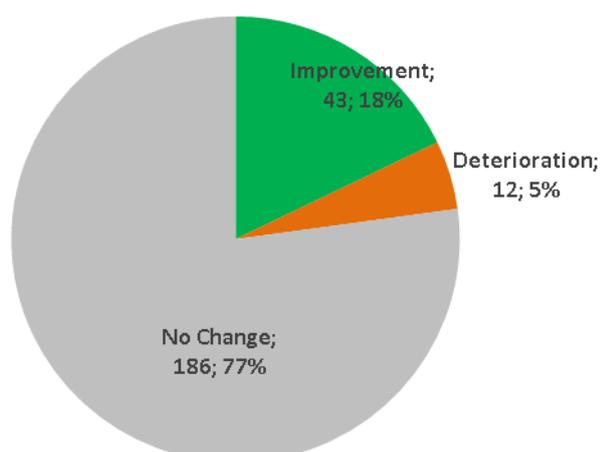
Figure 12: Distribution of changes by number of continuous 10-rkm-segments

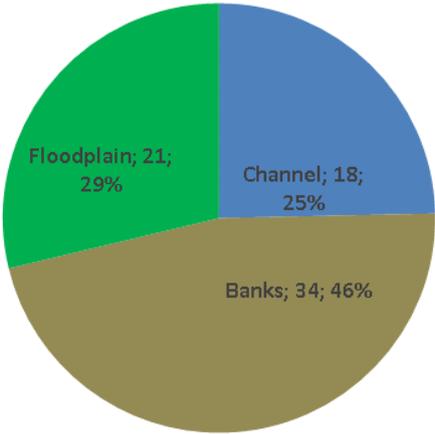
Figure 13: Distribution of prevailing changes for the main categories

The analysis of changes (Figures 13-15 and maps in chapter 2.2.3) is based on the total number of recorded changes (73) to keep transparently all records sent by the countries (from data collection tool). River bank changes (restoration or construction) prevail with 46% followed by changes of the floodplain (29%) including the reconnection of side-channels and 25% for the channel (Figure 13).

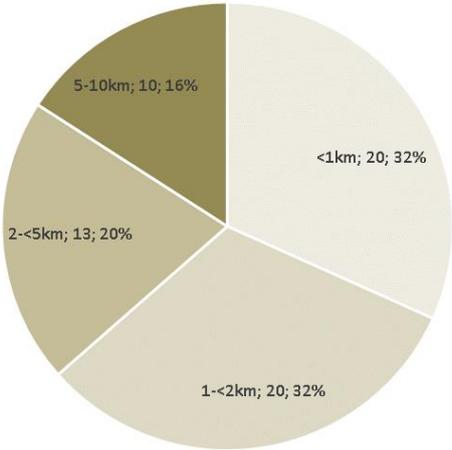
Figure 14: Length classes distribution in km for changes

The total lengths of all changes (73) cumulatively sums up to 159.69 km. Regarding the length of the changes, rather “short and small” projects predominate. The exception are fish passes opening entire 10-rkm-segments for migration of biota. Short measures < 2 km comprise 64% of all changes, but only 37.99 km or 24% of all changes by total length (Figure 5). The average length of changes is about 2.2 km, but excluding the full length of 10-km-sections for continuum restoration by fish passes, the average length dropped to 1.7 km.

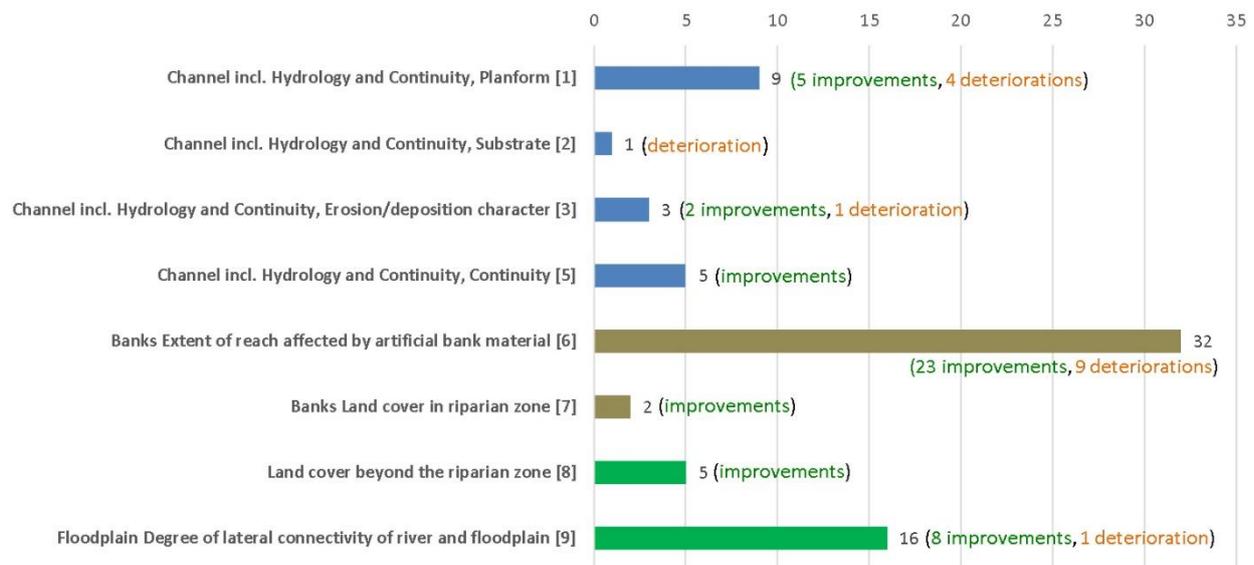
Figure 15: Types of restoration/alteration per all individual changes (blue for “Channel”, brown for “banks” and green for “floodplains”) and number of improvements/deteriorations per type.

Most of the changes are related to river bank development [parameters 6 & 7] with in total 34 changes (Figure 15). The removal of rip-rap clearly prevails with 23 cases. Side channel connections [9] as mainly improvements are rather frequent (8 times) followed by channel changes [1], which are recorded in junction to side-channel connections on the Middle Danube (five times), but also as deterioration (four times due to infrastructure and dredging activities on the Lower Danube). As already mentioned, parameter [5] for continuum improvements are realised entirely in the Upper Danube. Merely the parameter [4] on changed flow conditions and regime by structures (groynes, dams with impoundments) was not reported at all.

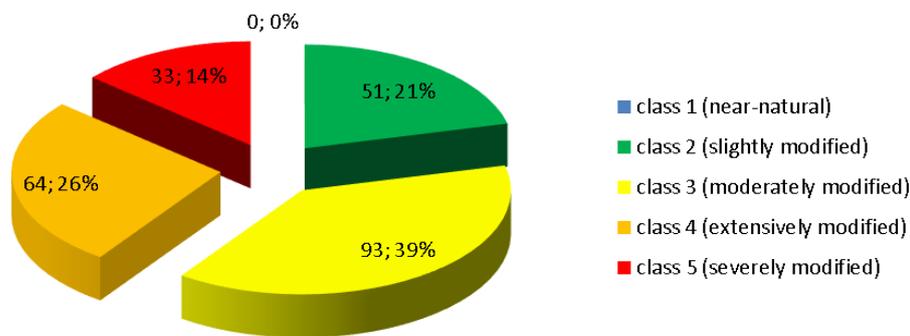
Figure 16: Overall assessment of JDS4 as based on JDS3 with only slight changes (shift of two segments from class 3 to 4, no change in percentage)

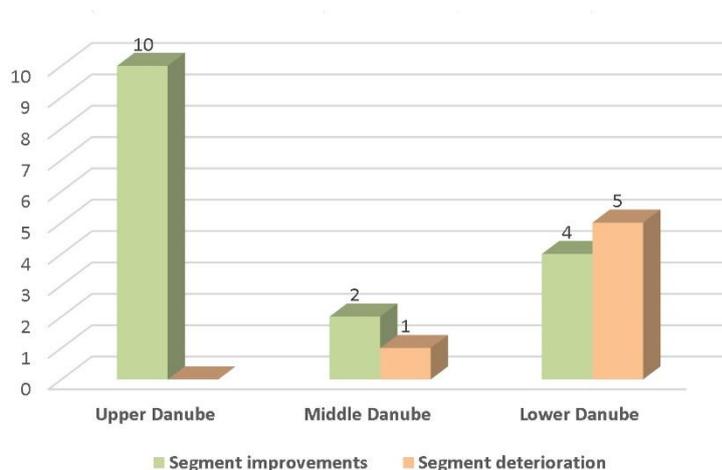
Figure 17: Overview of segments with changes for at least one parameter group (channel, banks, and floodplain) along the three main section of Danube

In general, the recorded changes imply many improvements in the strongly altered Upper and partial the Middle Danube while on the Lower Danube a few deteriorations prevail (Figure 17), however, based on the much better original JDS3 assessment for the Lower Danube in comparison with the Middle and Upper Danube and the deteriorations are spatially limited. In the total perspective, the positive aspects predominate, regarding the fish continuum the construction of bypass solutions for Austrian dams is an important step. Several side-channel connections including SK and HU are good examples for the proceeding restoration. The reason why more segments on the Upper Danube improved in comparison to the Middle Danube, can be explained with the worse situation before in DE and AT, while the free-flowing SK and HU reach assessment in the third moderate class was closer to class four instead two.

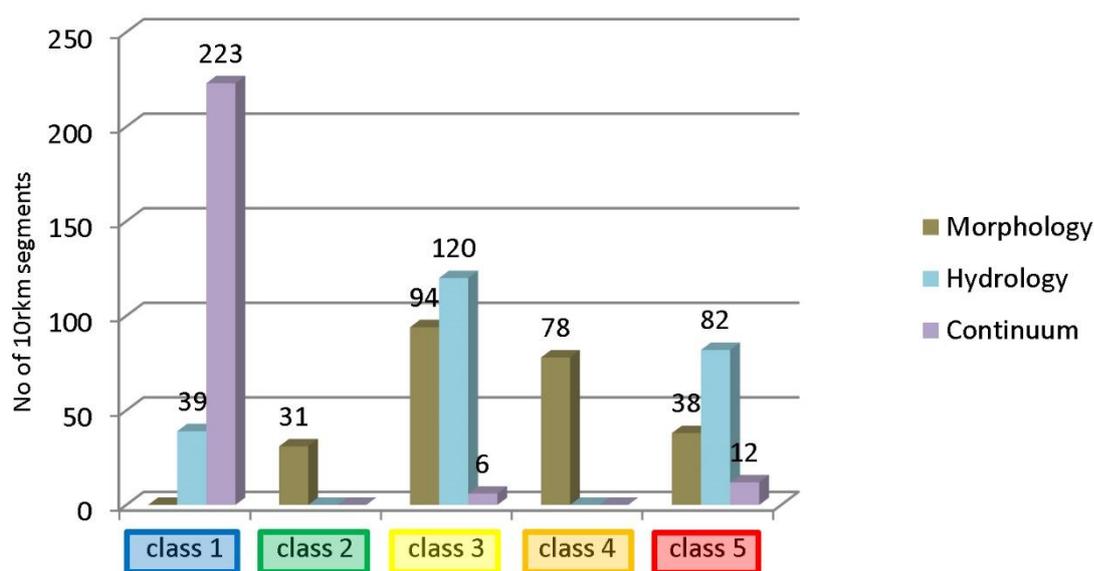
Figure 18: WFD 3-digit assessment as based on JDS3, mainly changed for the continuity for fish by the construction of fish passes in AT (hydrology and continuum were assessed only in classes 1, 3 or 5).

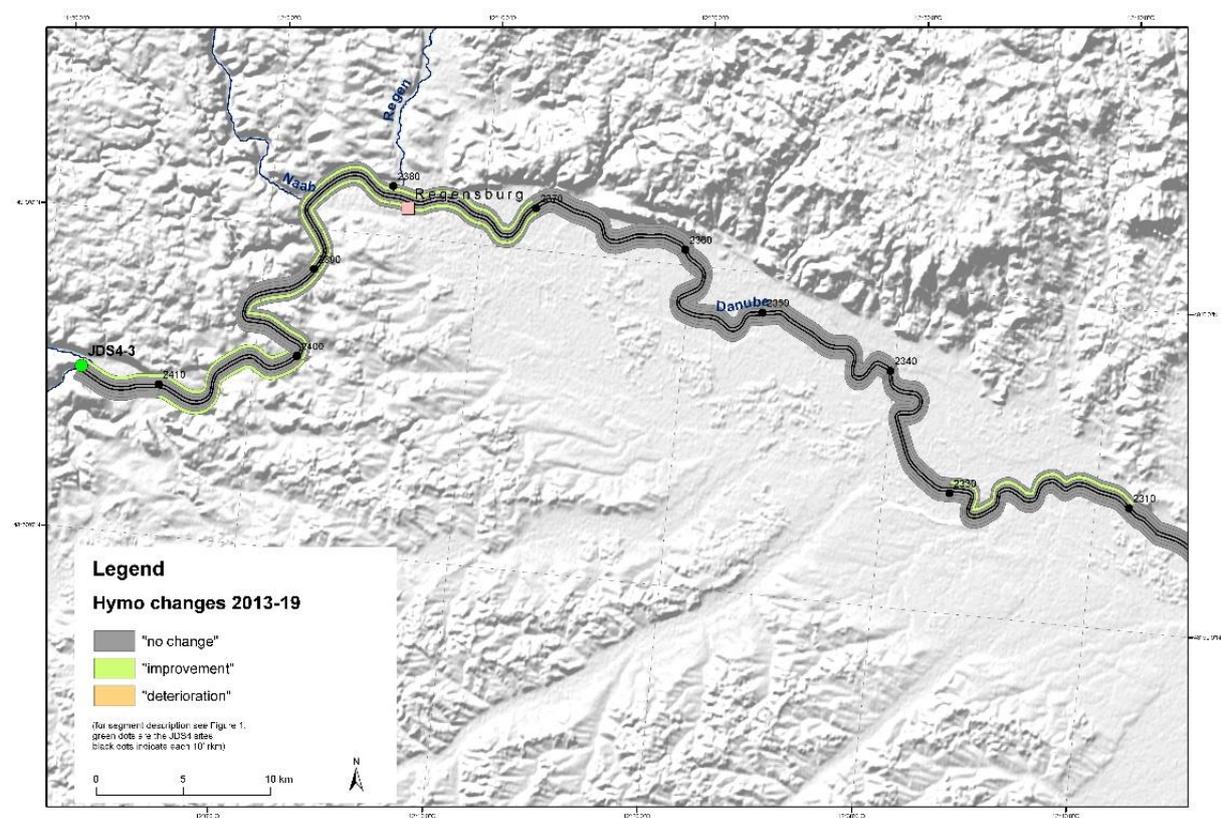
Figure 19: On the Upper Danube between Kelheim and Regensburg, many small-scale measures to improve banks and partially floodplain were implemented. However, the degree of alteration remains very high, the entire reach is impounded (green dots in the maps mark the JDS4 stations).

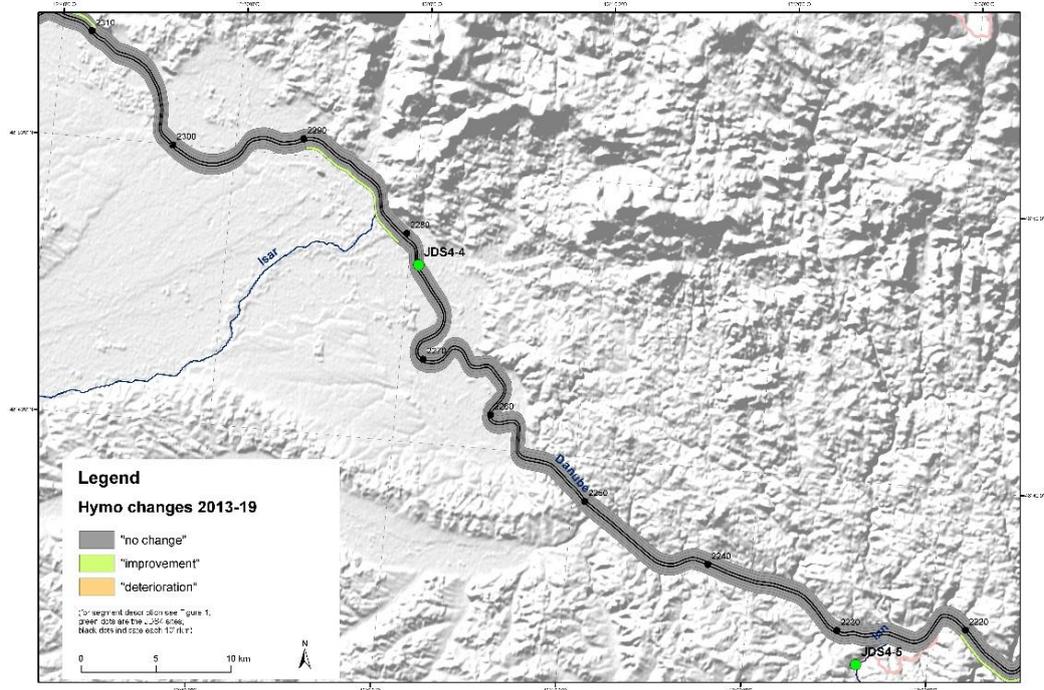
Figure 20: In the free-flowing section downstream of Straubing, but in particular opposite to Deggendorf, close to the Isar mouth banks and the floodplain have been partially restored. The floodplain restoration near Deggendorf is the only active flood dike repositioning (to increase retention volume) along the entire Danube in the reported period).

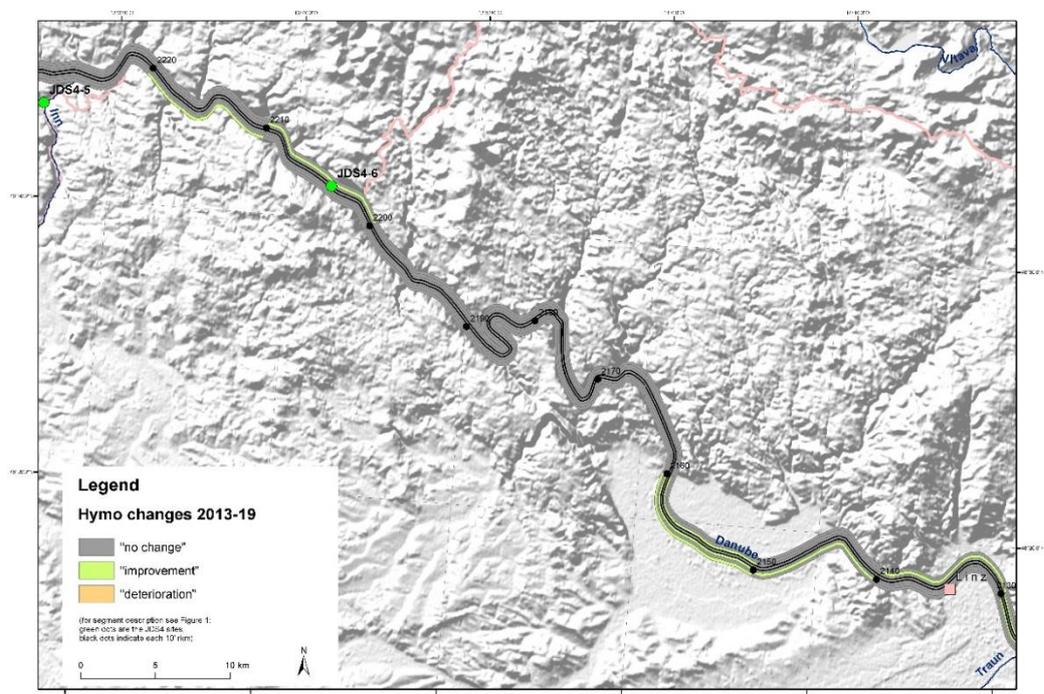
Figure 21: In the border reach DE-AT some improvements on right floodplain and left bank (backwater Engelhartzell) happened. Upstream of Linz local measures cover works in the right floodplain (connectivity, fine sediment removal) and shorter sections of bank improvements.

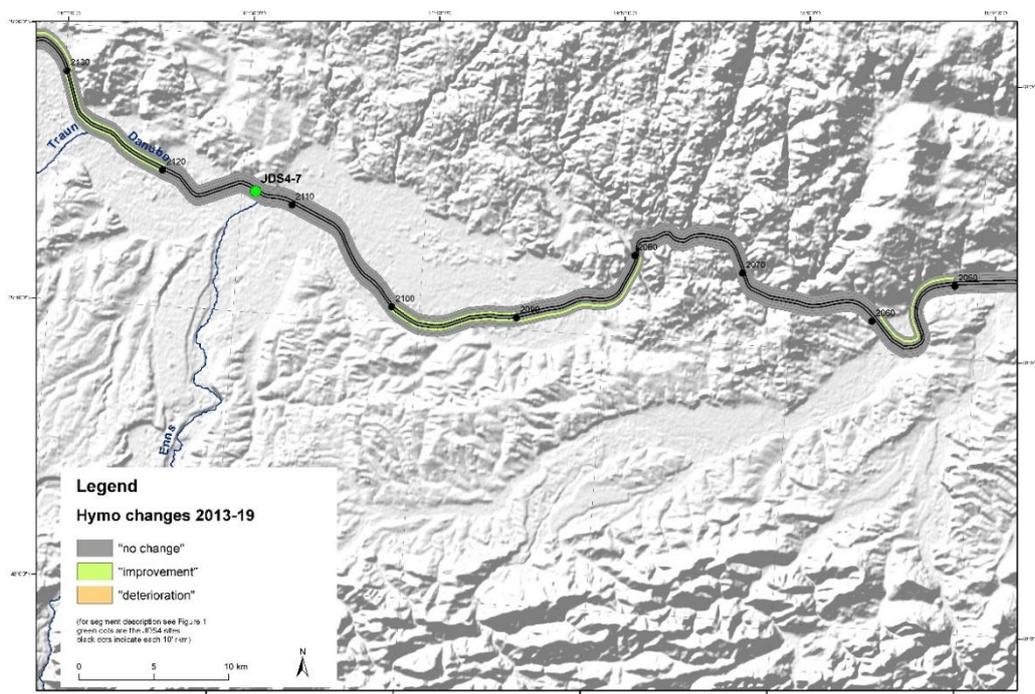
Figure 22: Downstream of Linz the new fish passes for the two hydropower plants, Abwinden Asten and Wallsee-Mitterkirchen must be highlighted. Further activities can be find in the upper backwater reaches by introducing gravel banks.

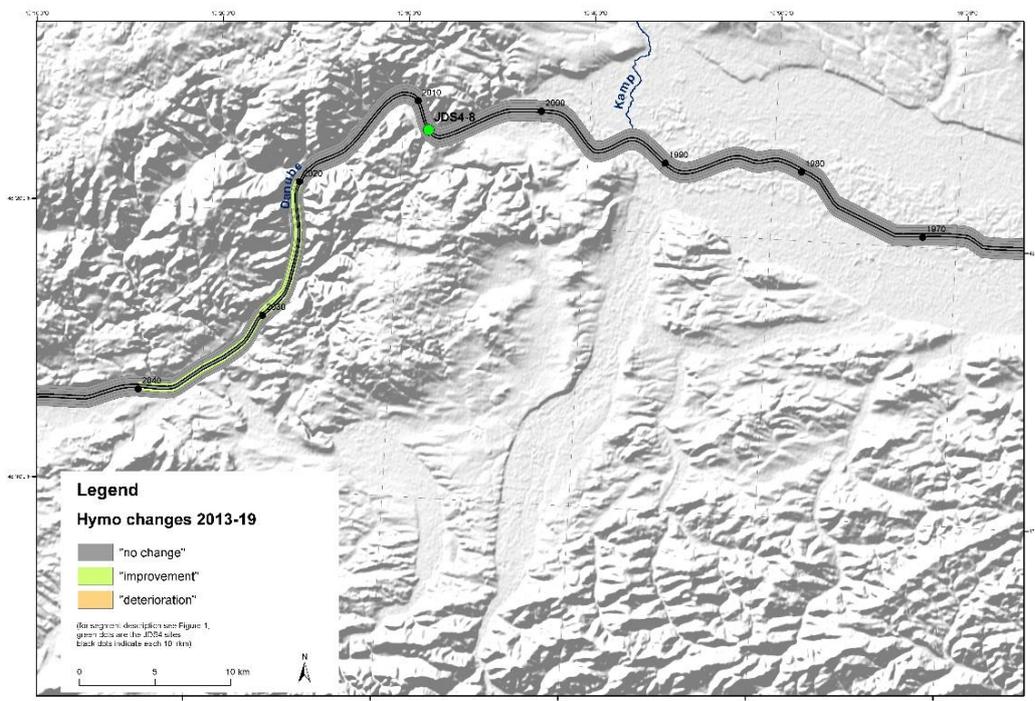
Figure 23: The free-flowing Wachau reach was and is subject of several restoration projects, mainly co-financed by Life projects. Aside of the creation of gravel bars, the deposition of gravel bars near the banks is characteristic for the restoration type of this reach. However, the incision downstream of the hydropower plant Melk is still considerable and most probably further additional Material must be supply.

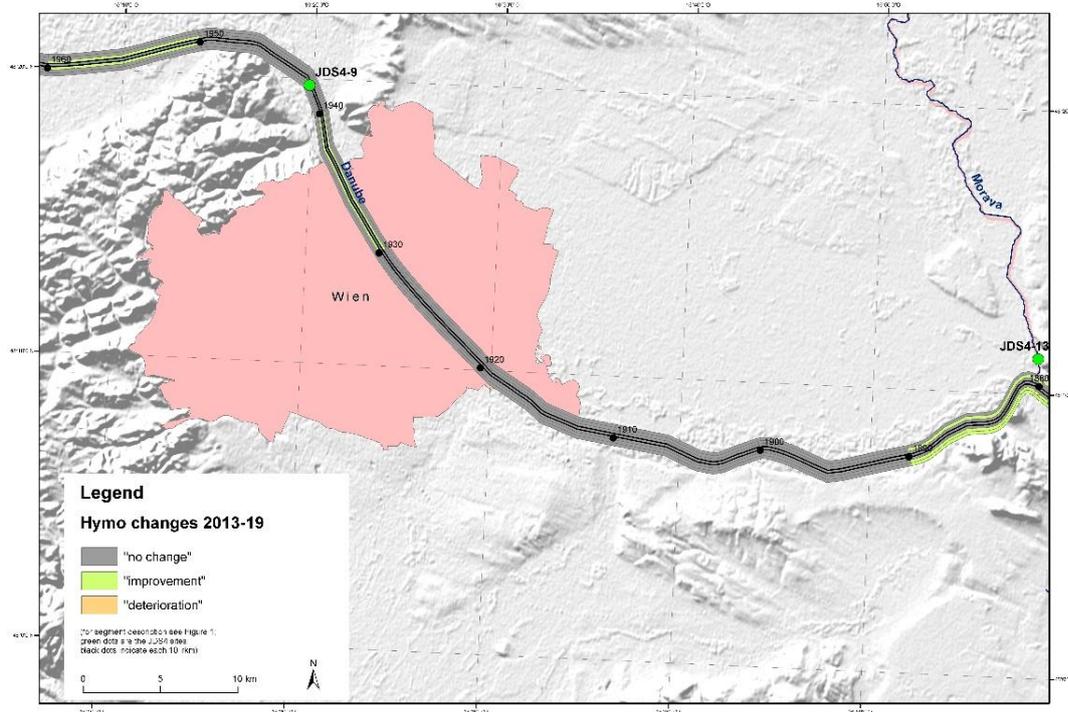
Figure 24: The fish pass in Greifenstein is the third dam equipped between 2013-2019 opening another barrier upstream. The Danube east of Vienna is subject of many restoration projects within the past 30 years and therefore a kind of pilot area at least within the Danube basin. Two segments tend to reach a better class in overall assessment and the two large scale side-channel connections near Haslau and Stopfenreuth will realise this goal in the next years.

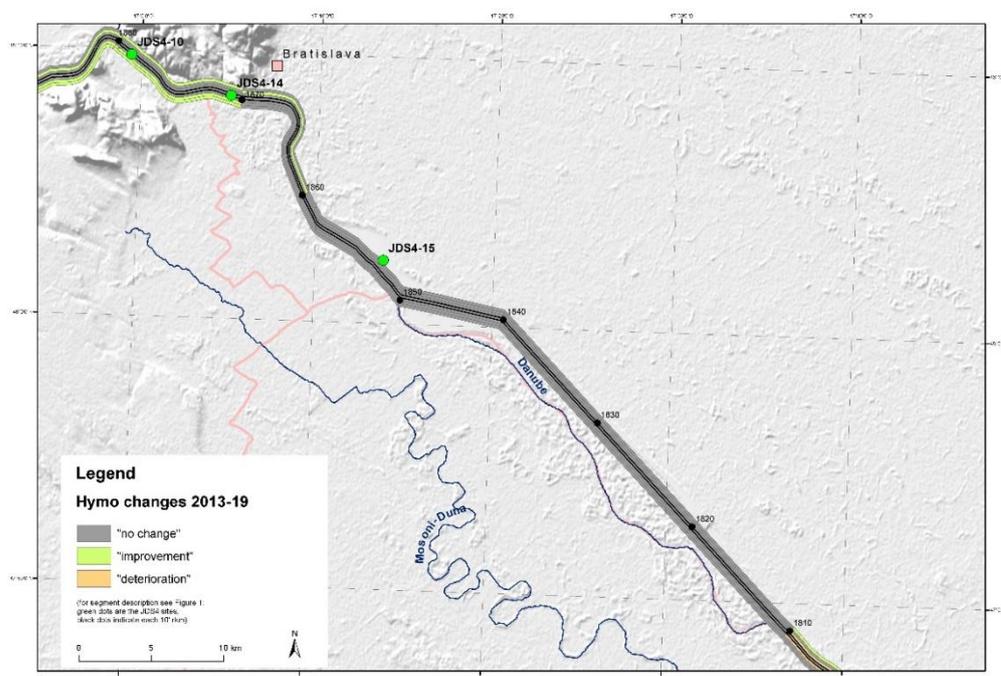
Figure 25: Also alongside the AT-SK border stretch restoration activities can be recorded on both side of the river, befor the Gabčíkovo backwater begins in Bratislava.

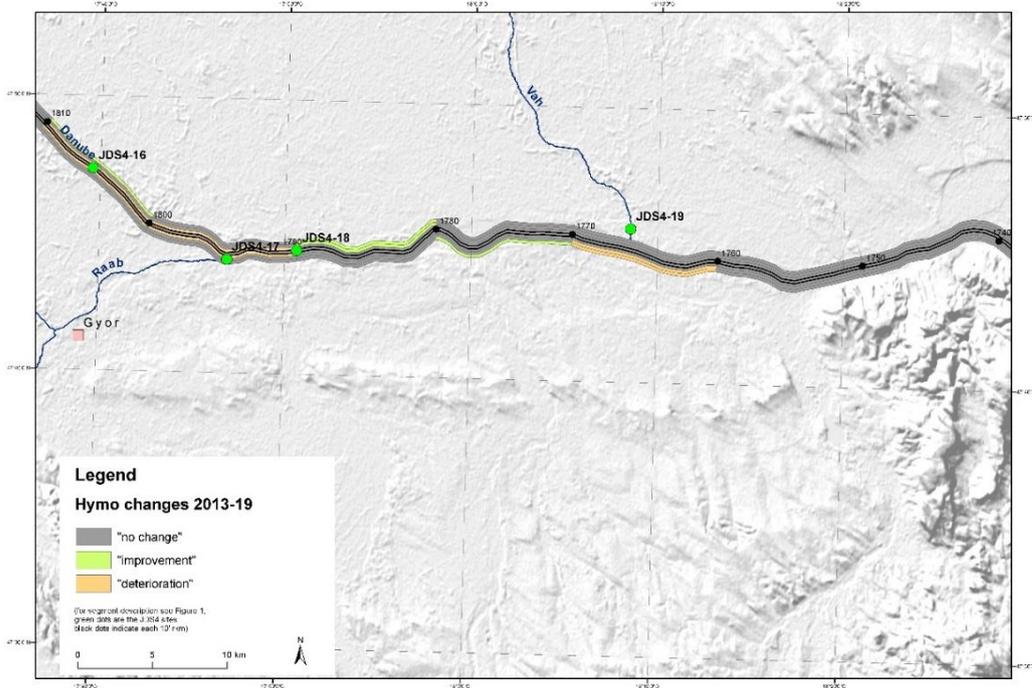
Figure 26: The border stretch SK-HU is characterised by the restoration of two larger side channels in SK and one floodplain improvement in HU. However, the ongoing deepening of the channel downstream of the Gabčíkovo dam “neutralize” from an international viewpoint the development. In Komárom new flood protection reduces the right floodplain area.

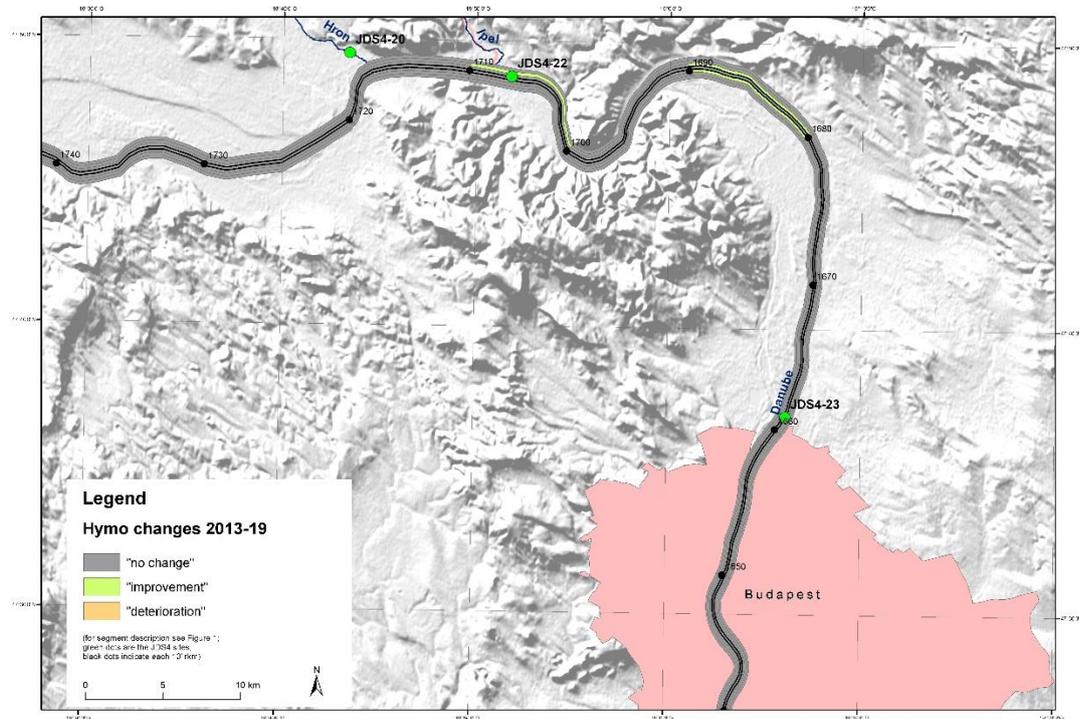
Figure 27: in the Danube bend, several smaller improvements on banks and channel can be registered, but not leading to improvements of assessments.

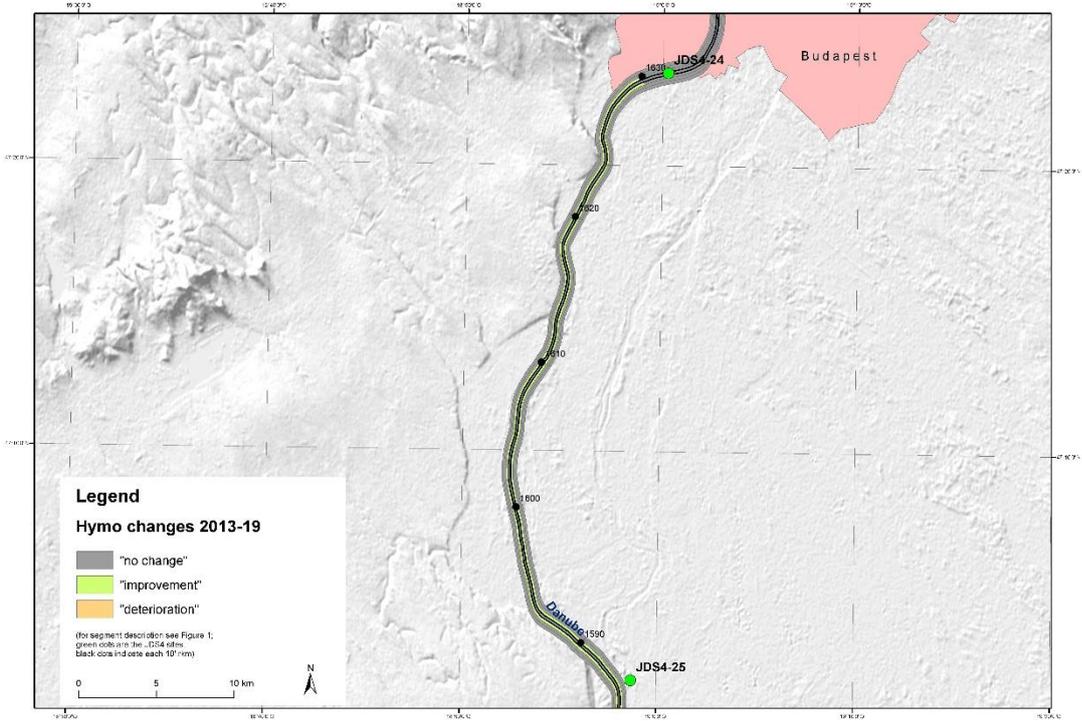
Figure 28: South of Budapest several improvements on channel and side-channels/floodplain connectivity can be recorded. The biggest one is the restoration of a longer island near Adony (right bank near rkm 1,595).

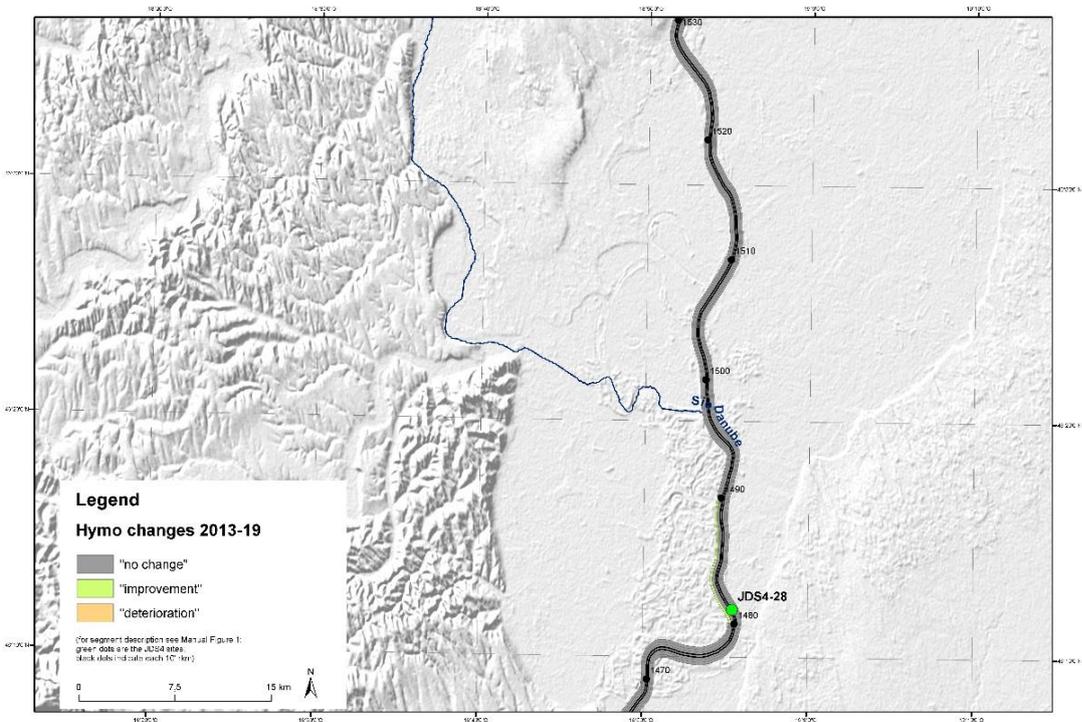
Figure 29: Within the Gemenc area extensive restoration works were implemented.

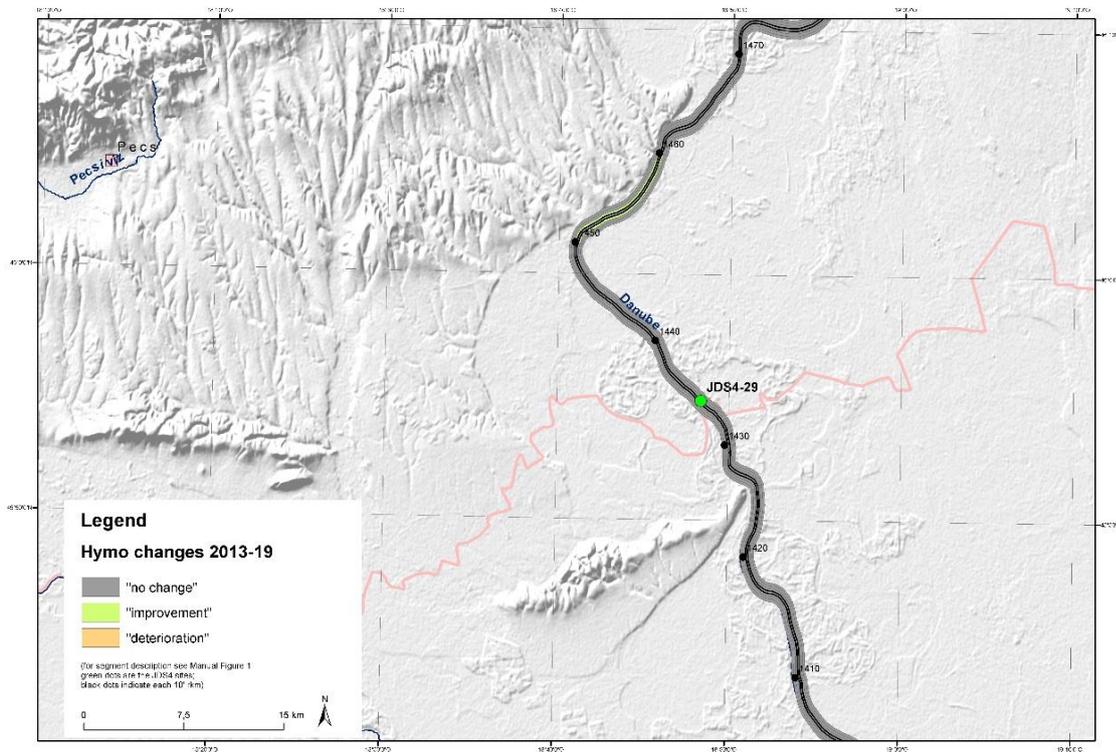
Figure 30: Upstream Mohacs (rkm 1,450) along the right bank, a side channel was subject of restoration works.

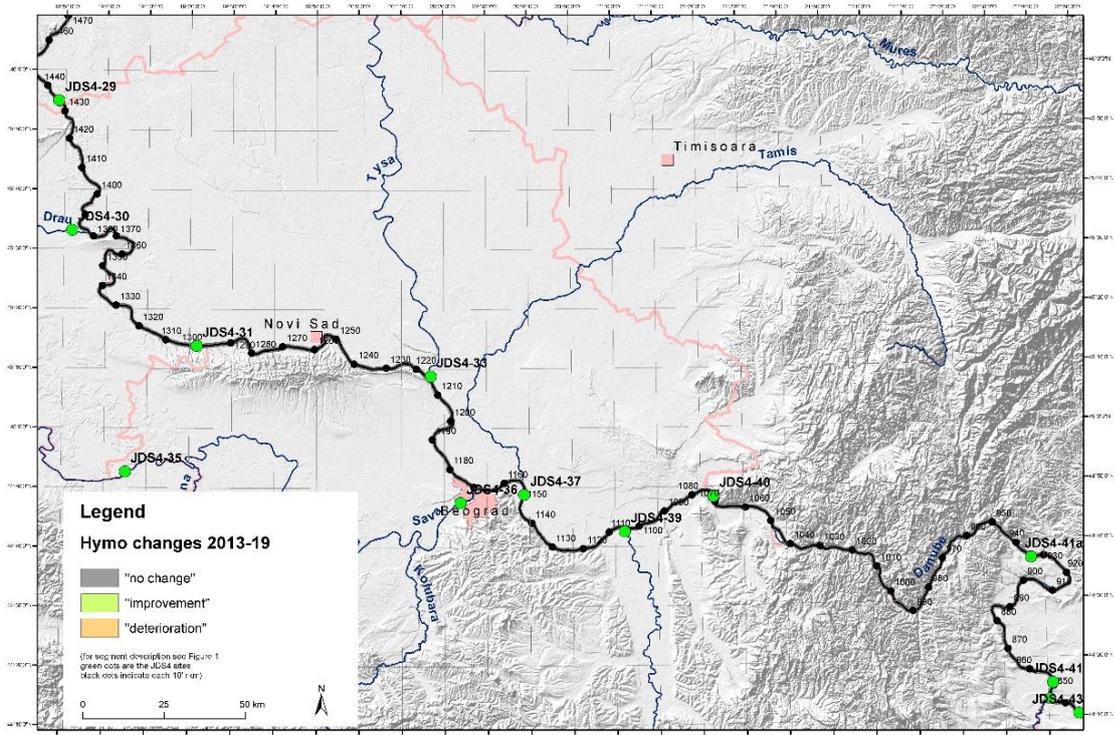
Figure 31: No changes are submitted for the free flowing stretch of Danube in Croatia and Serbia. Aside of minor groyne and Vukovar's bank wall renovation works before 2013, the upcoming period will bring new changes with the Waterway improvement programme, which is under way.

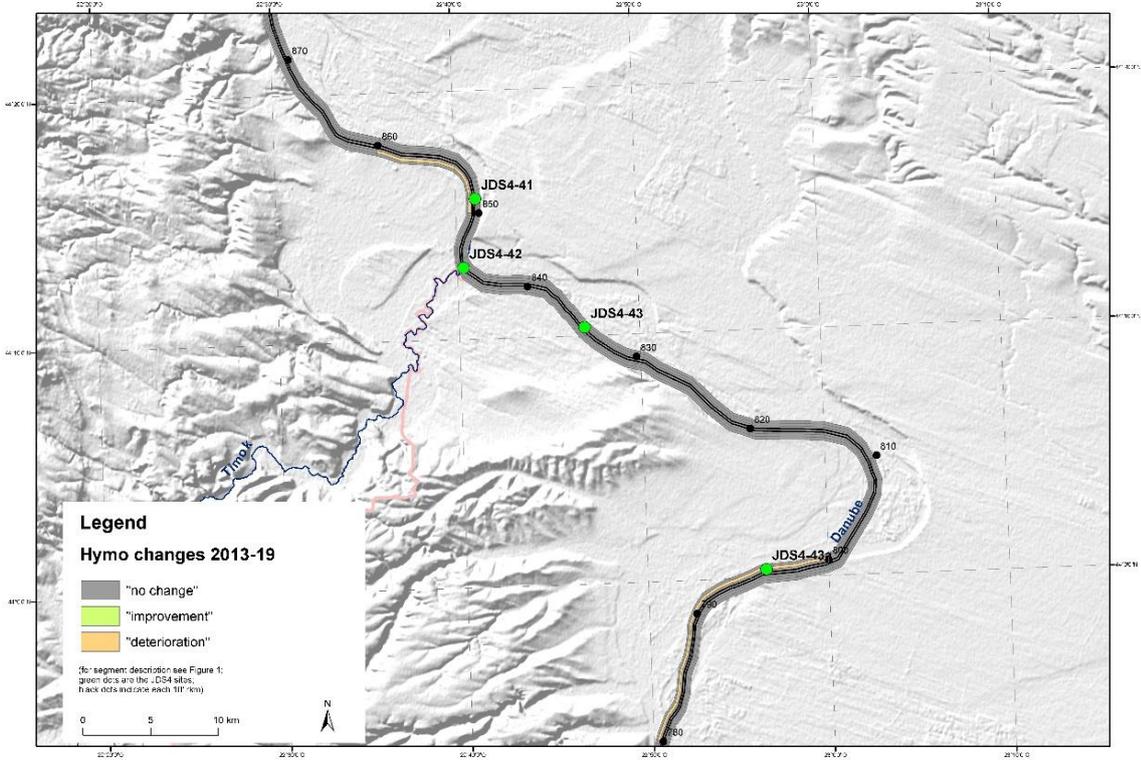
Figure 32: The only record for RS is given for a flood defence work just downstream of Iron Gate dam II, further deteriorations can be find downstream in BG.

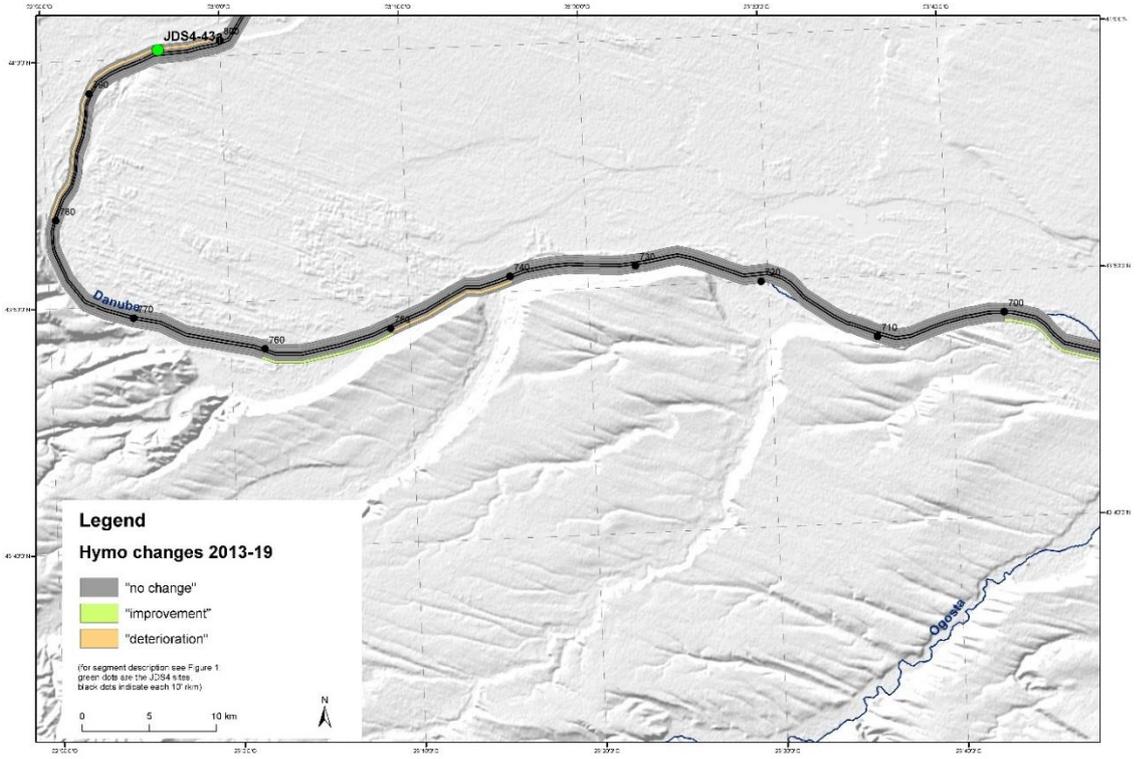
Figure 33: Some floodplain improvements can be find on BG river side.
