Joint Danube Survey 4

Recording and assessment of hydromorphological changes 2013 - 2019

Ulrich Schwarz

Date: 21.09.2020

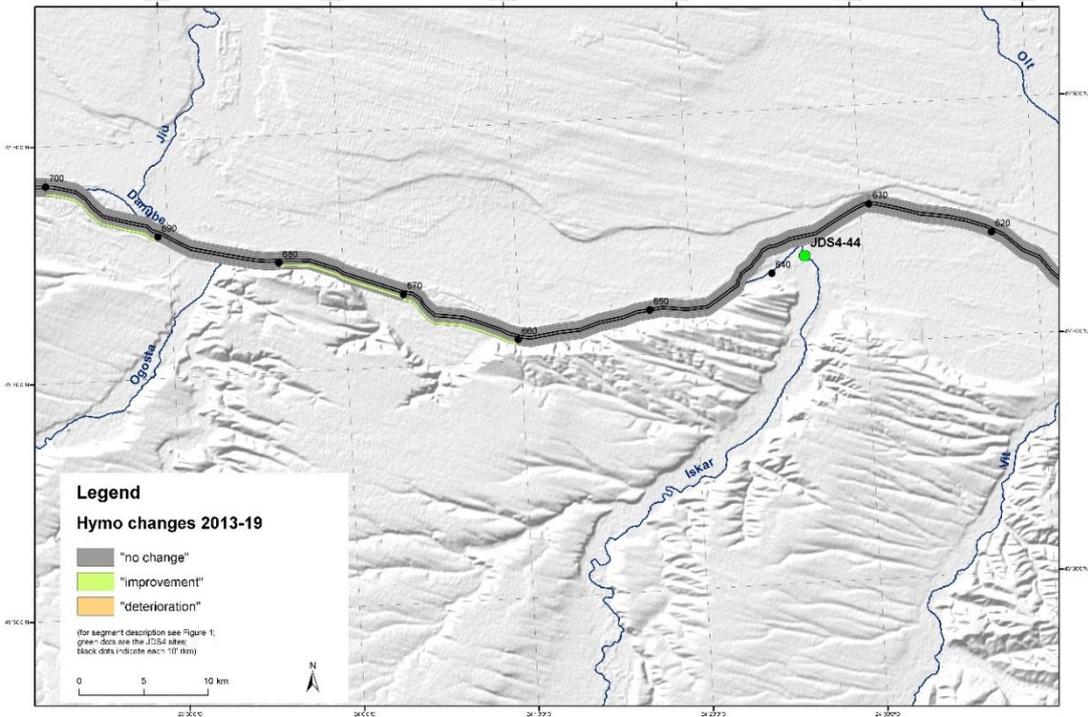
Figure 34: Bank and floodplain improvements prevail downstream.

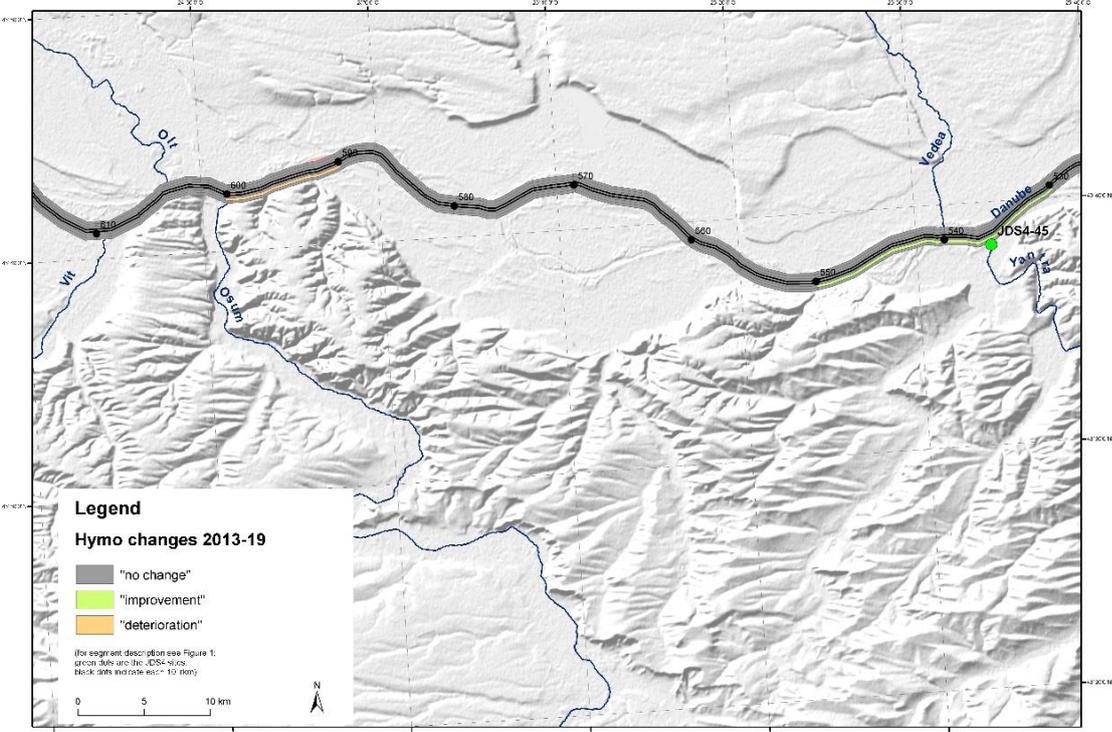
Figure 35: Same picture further downstream, some deteriorations in form of bank reinforcement are reported.

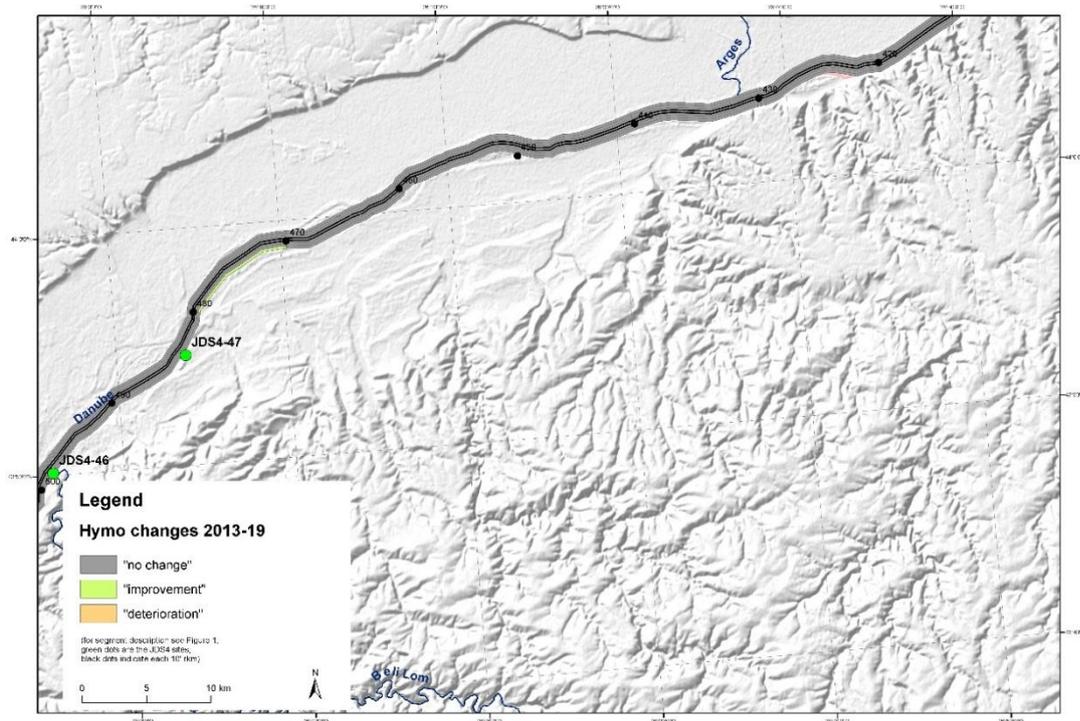
Figure 36: And another floodplain improvement in BG further downstream. Two short deteriorations at rkm 490-500 and 400-410 on Bulgarian side (50/90 meters long) are not included in the map.

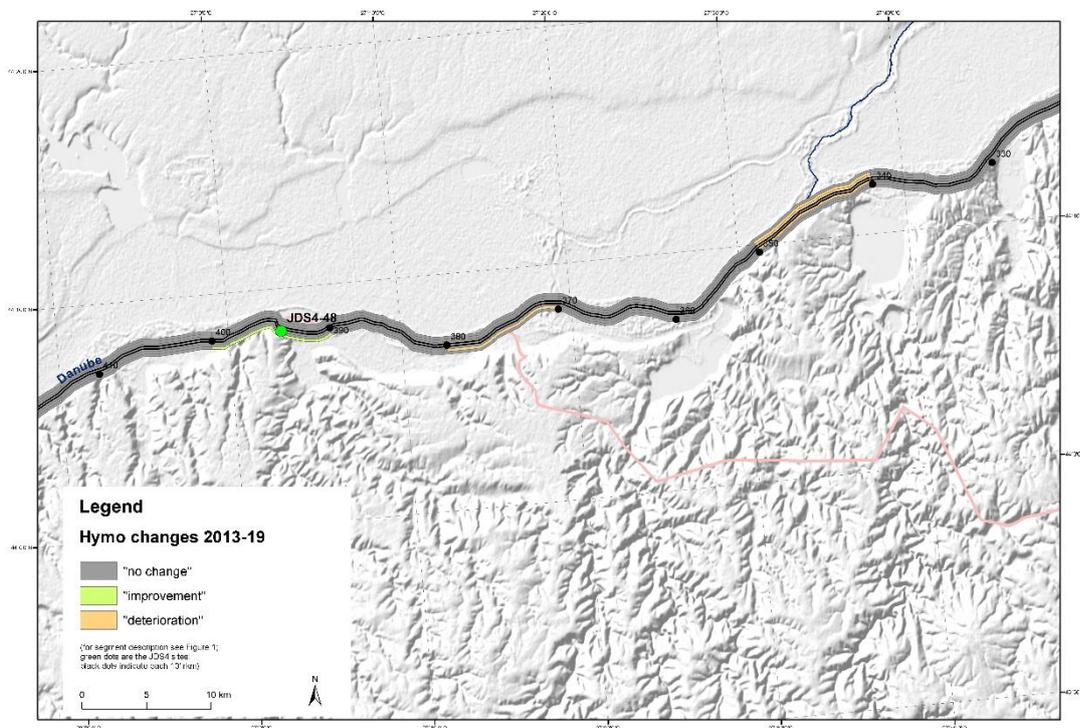
Figure 37: The Bala branch project with the introduction of a massive ground sill and the subsequent bank regulation of the channel entrance deteriorate the segment, even the sill is constructed in the Bala branch and not the assessed southern branch.

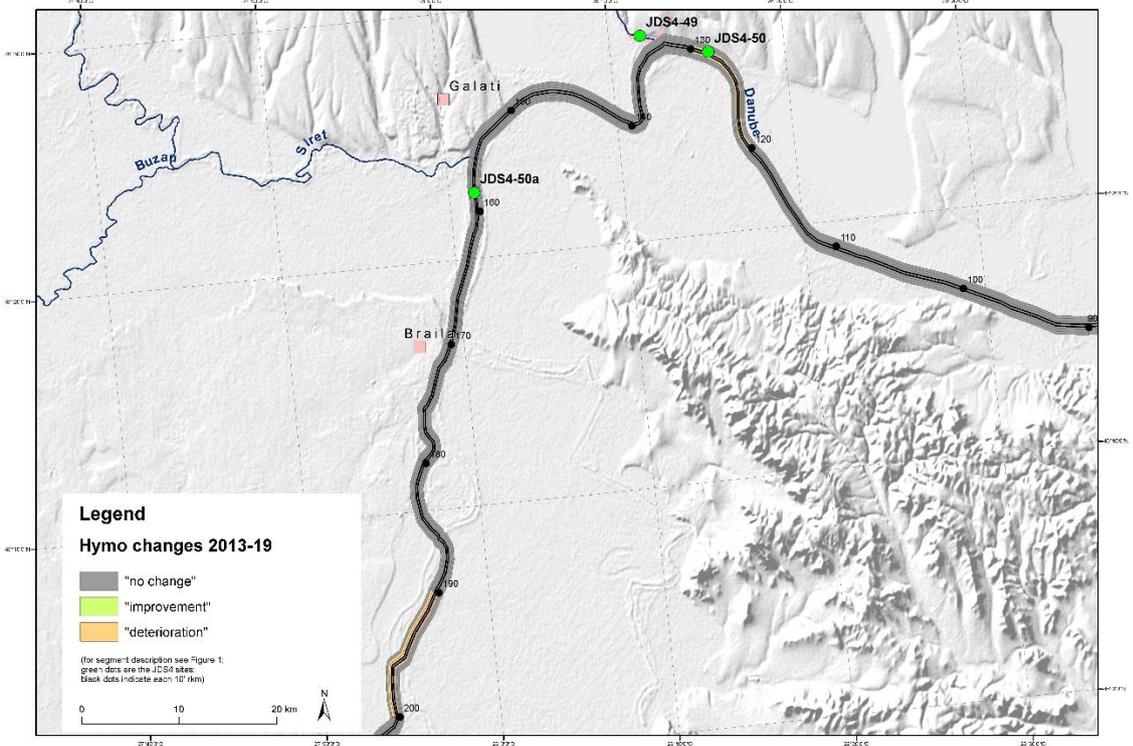
Figure 39: The only change recorded, by UA for the sea port Reni with is under expansion, which makes extraordinary dredging necessary.

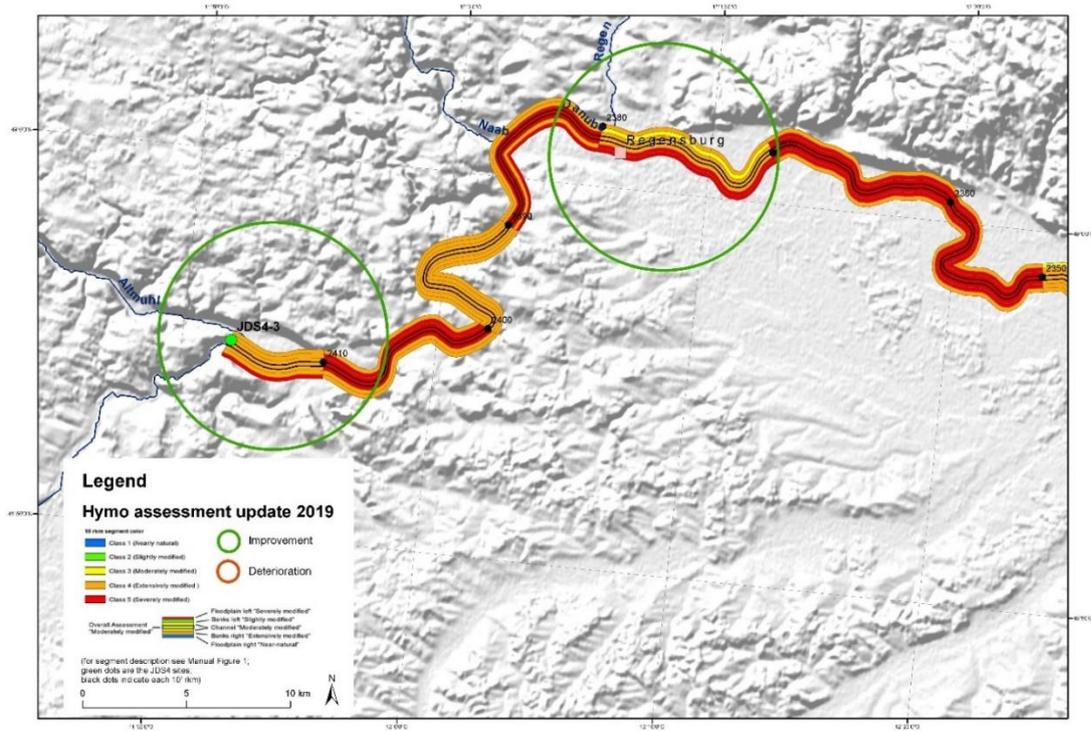
Figure 41: Two improvements for left floodplain and left river bank can be assumed for the Regensburg region.

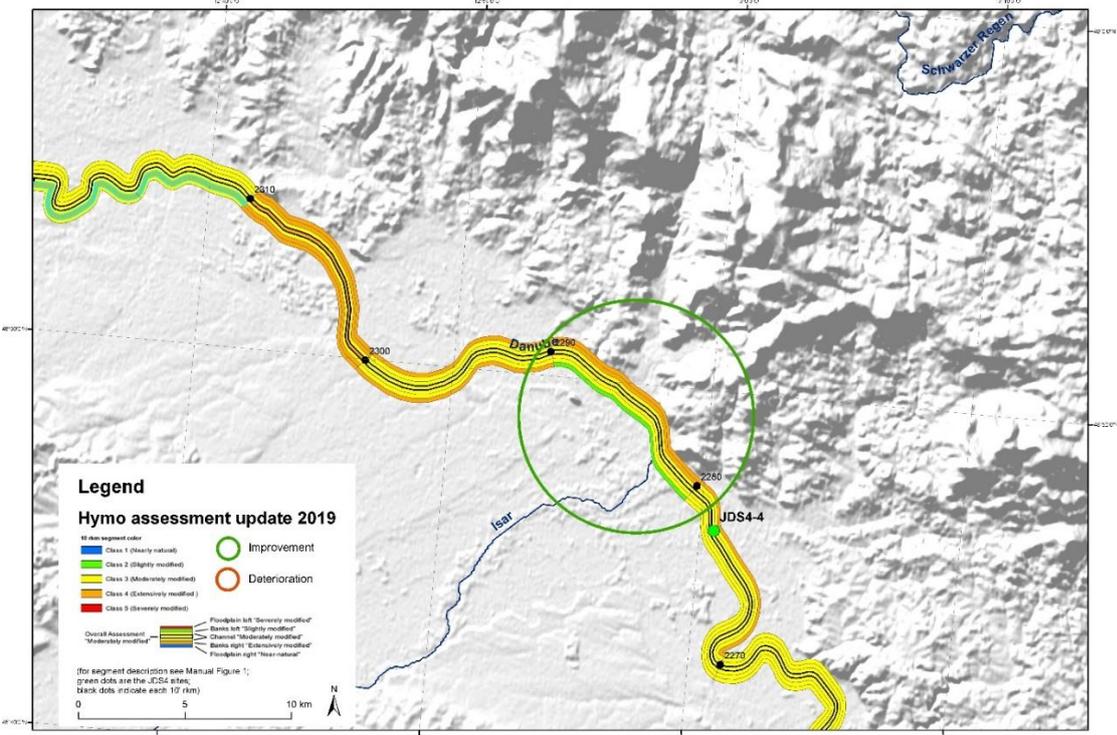
Figure 42: Even the lateral expansion of the floodplain opposite to Deggendorf is limited, the whole complex with the Isar mouth become much more quality, leading to raise in assessment.

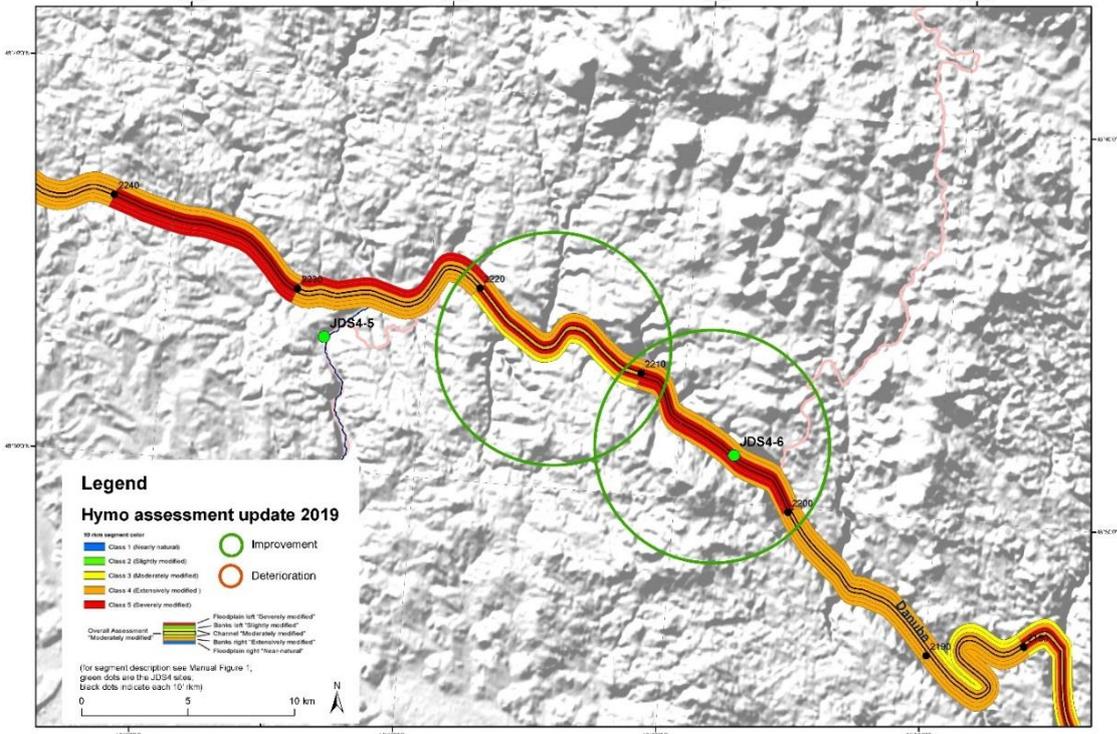
Figure 43: The two segments in the DE-AT border reach are improved within the right floodplain and left bank respectively. No change in overall assessment

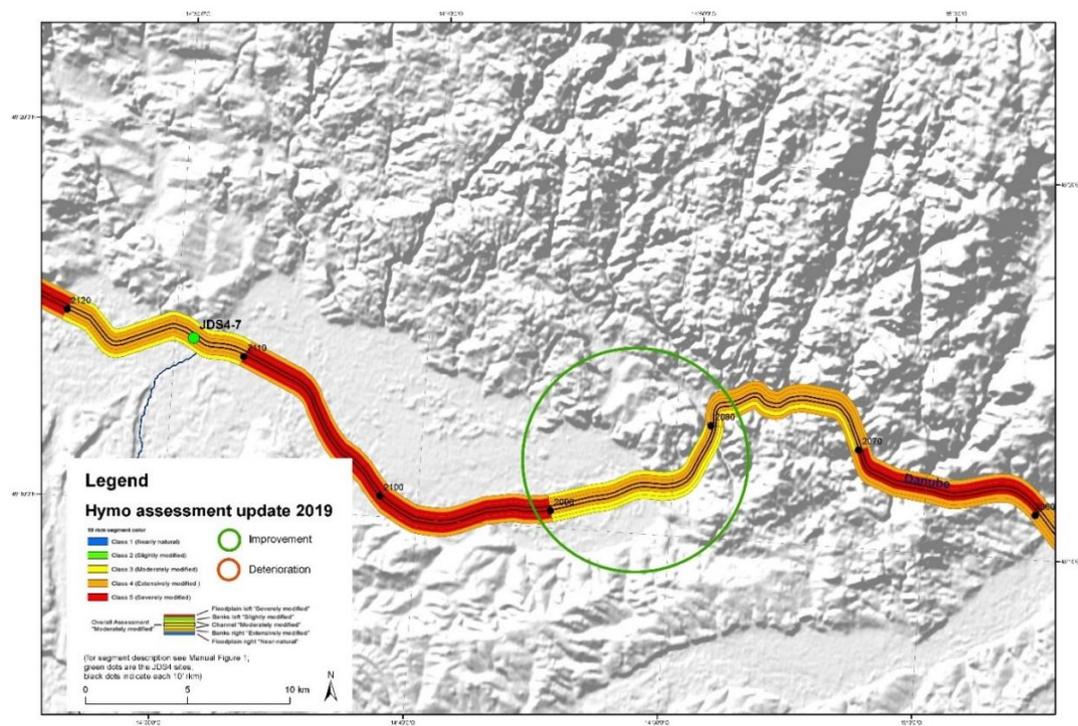
Figure 44: Also to no overall change lead the bank improvement in the upper backwater of Ypps-Persenbeug dam, At this point it must be stated that the two fish passes built in the red segments upstream do not lead to a class change of channel, as many parameters are evaluated. However, the WFD 3-digit assessment (see chapter 3.2.2 above) was lifted in the class 3, as partial restored continuity (for fish, but not for sediment).

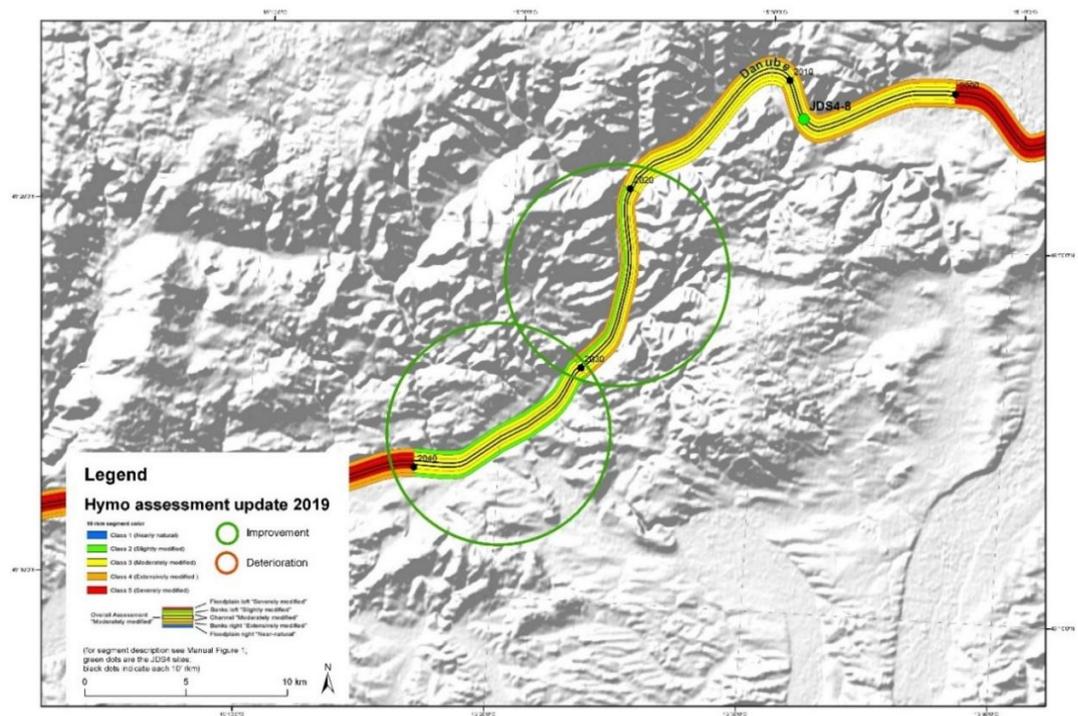
Figure 45: The Wachau reach has improved by bank and bar restoration as well as the introduction of gravel bar deposits.

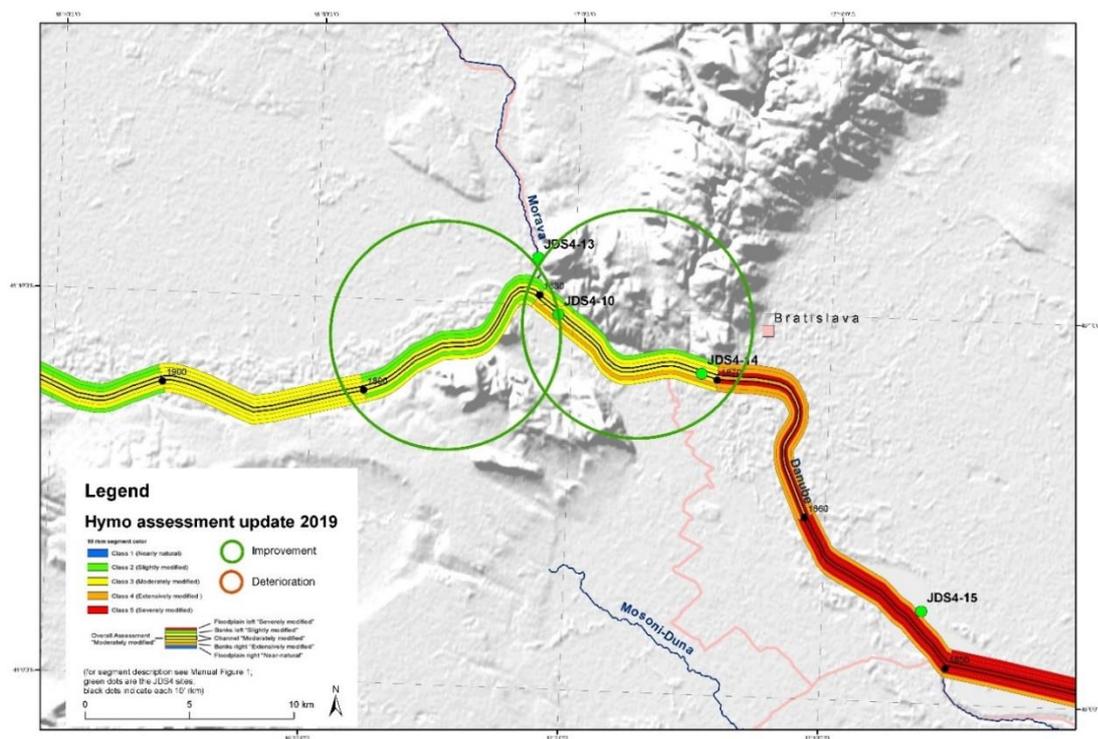
Figure 46: As mentioned the restoration works in the Hainburg 10-km reach raise the assessment of right bank (Johler side-channel and restoration). In future both segments visible in the map will be further restored by side-channel connections and rip-rap bank removal.

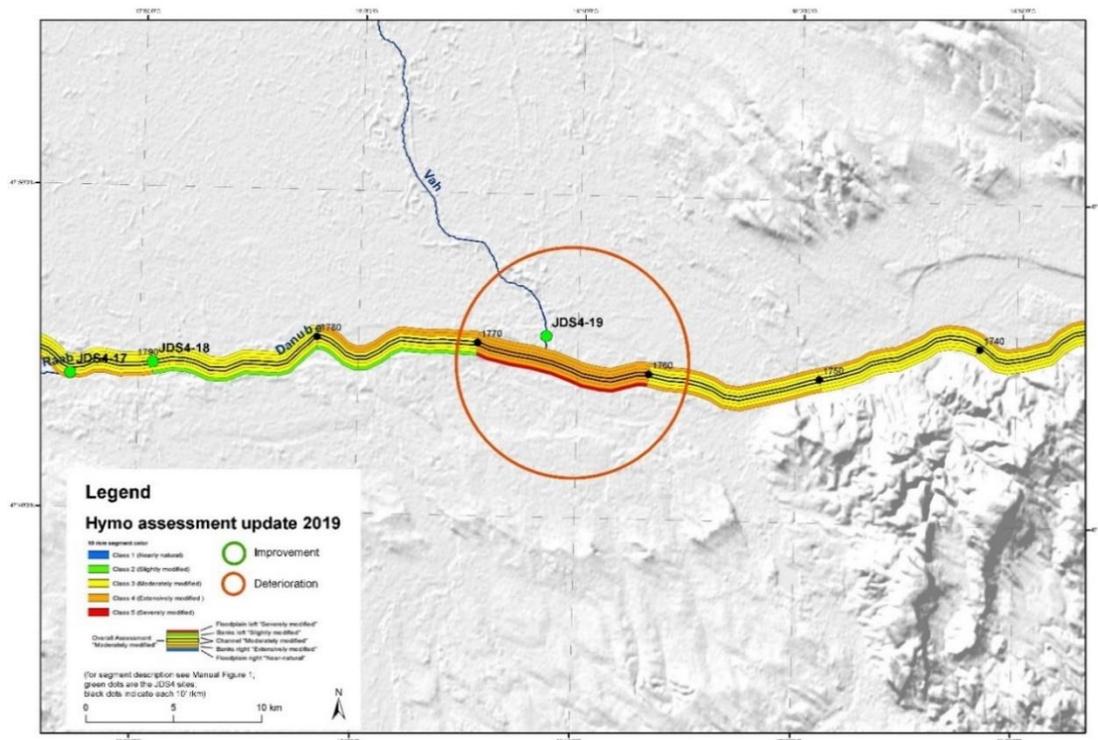
Figure 47: The flood defence (after the critical situation during the 2013 flood) east of Komárom lead to the first deterioration, visible in the assessment.

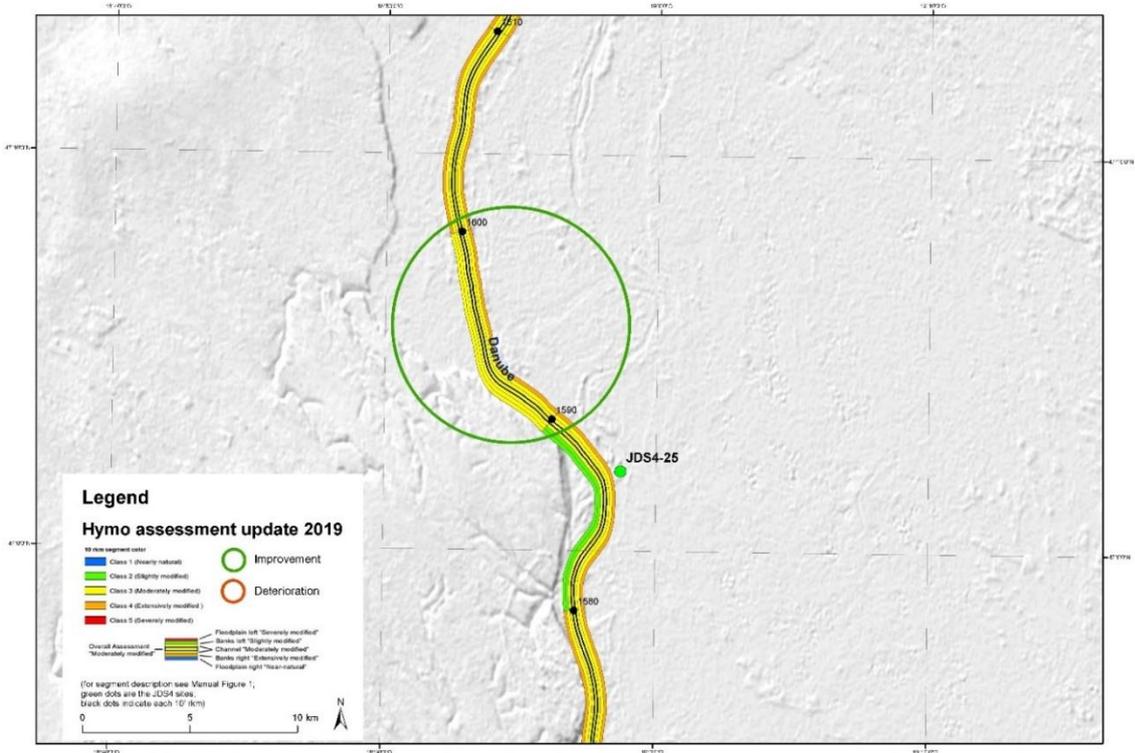
Figure 48: The Adony side-channel restoration raise the assessment for floodplain in the segment.

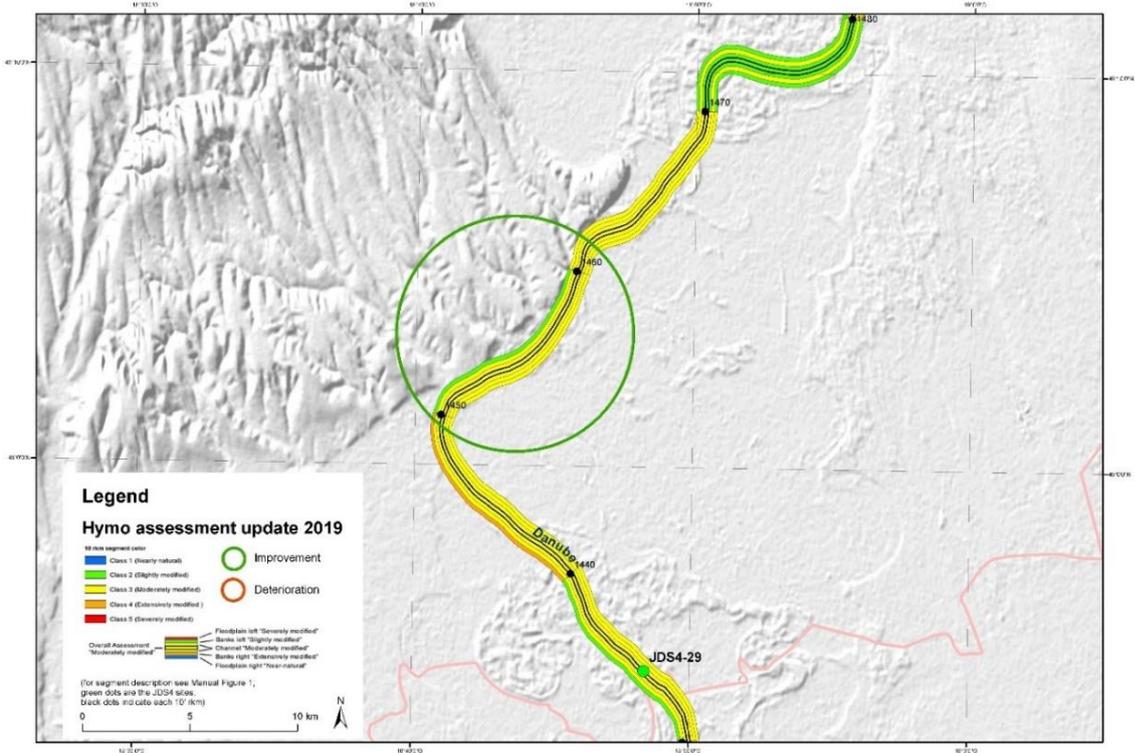
Figure 49: Upstream Mohacs another right wing side-channel within the Duna-Drava National park is subject of a restoration project.

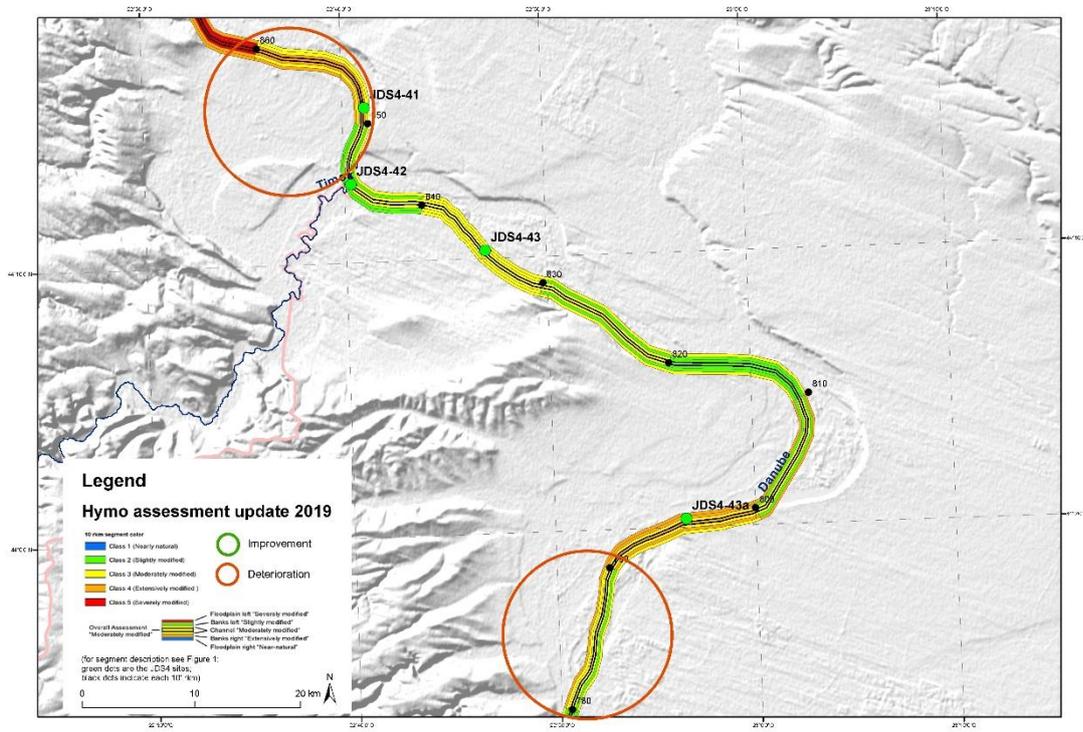
Figure 50: Downstream of Iron gate II dam a nearly 3 km flood defence on right side lead to the shift in overall channel assessment. Downstream in the Vidin area in BG, deteriorations lead to changes in bank section only, the city reach was already assessed in class 4 before.

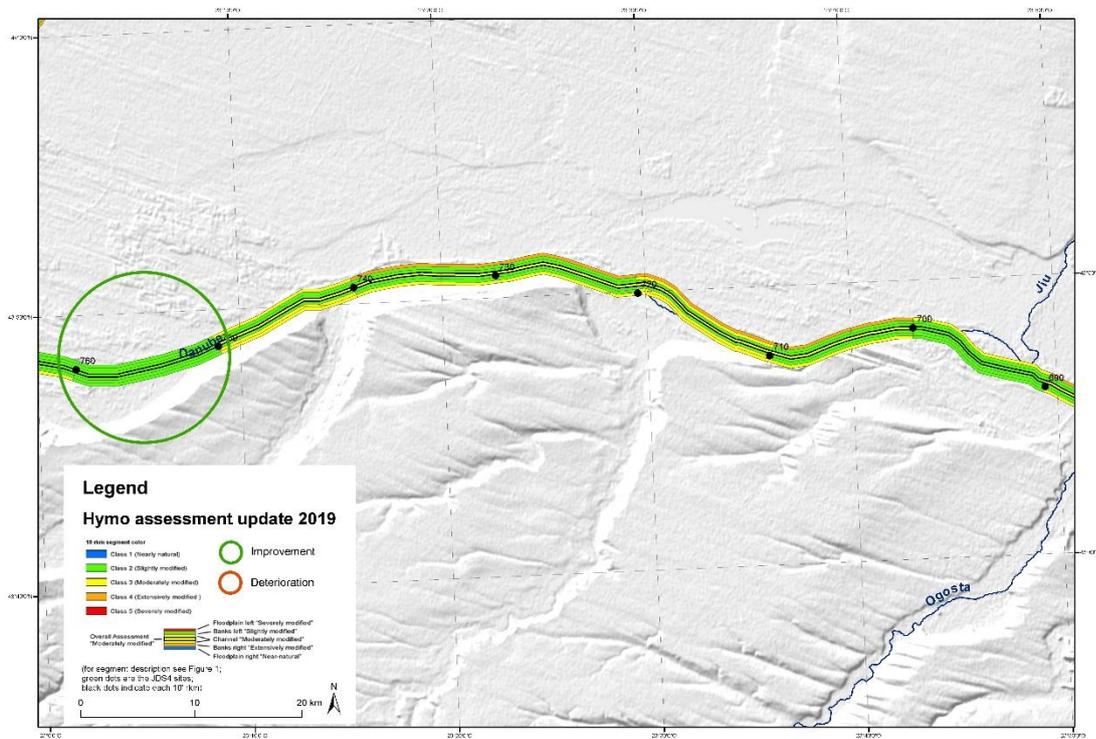
Figure 51: Three changes were recorded for the visualized reach but only the uppermost lead to a sub-segment change in right floodplain, but not for overall assessment.

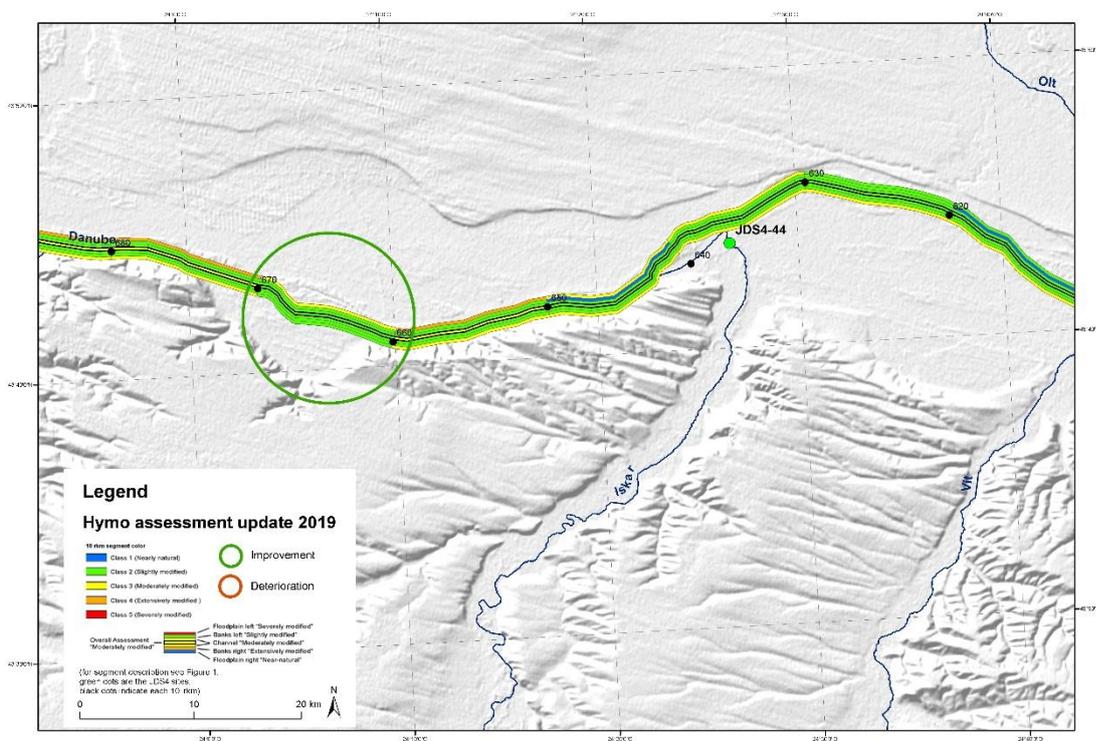
Figure 52: Regarding the two improvements on BG river side only one lead to an assessment improvement for right floodplain.

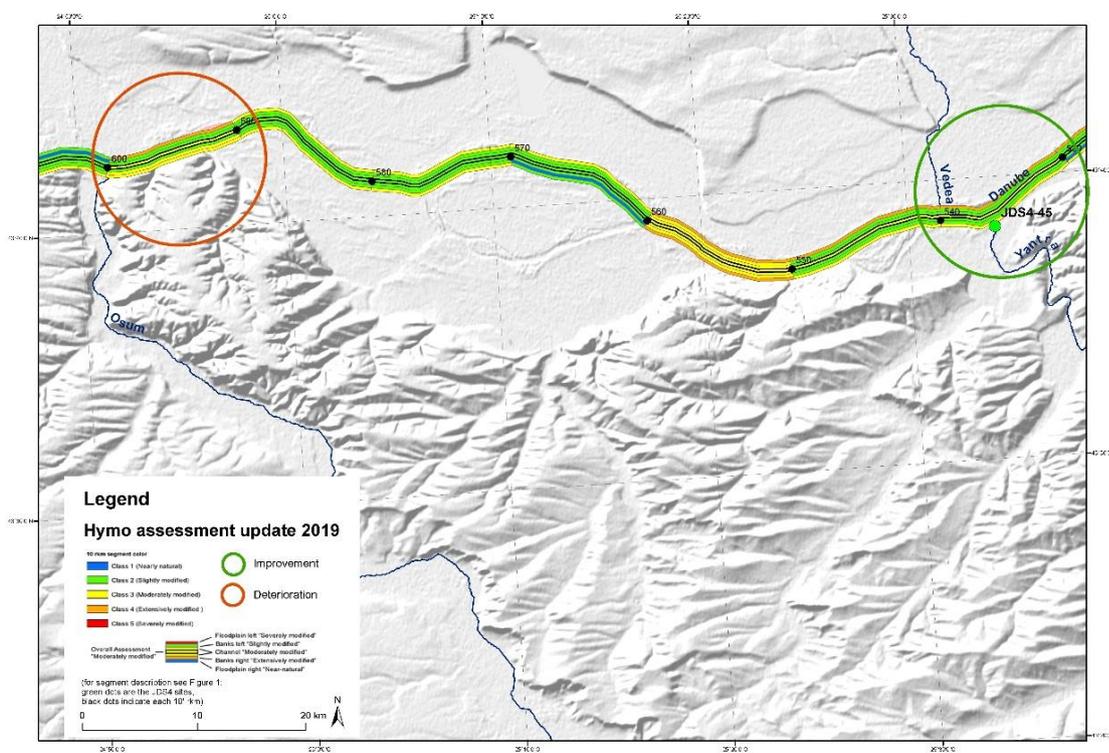
Figure 53: Out of three changes in the respective reach only two lead to changes for bank segments, no change in overall assessment.

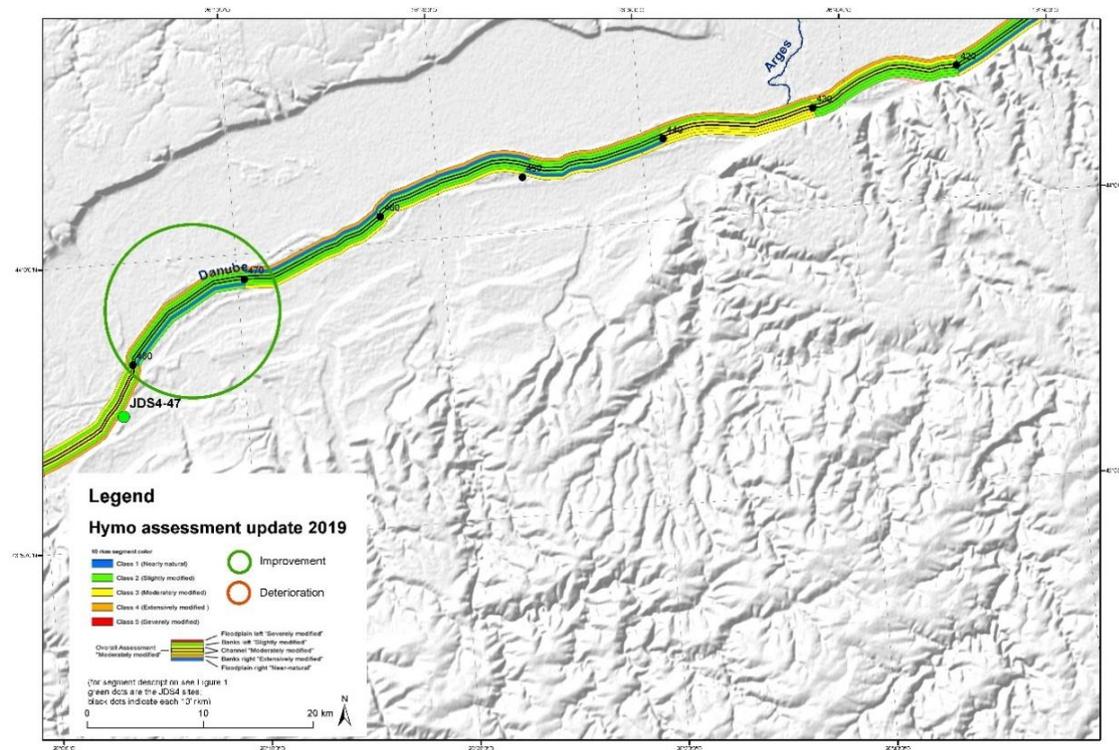
Figure 54: The right floodplain improvement in BG does not change the overall assessment.

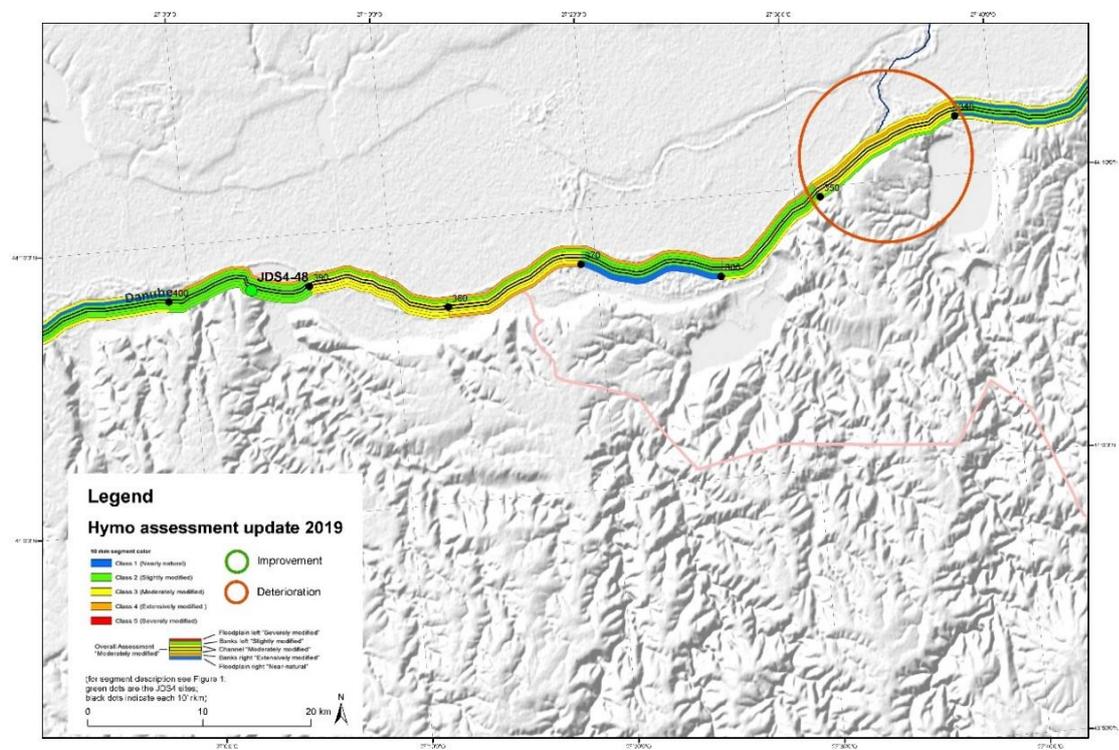
Figure 55: Bank revetments limiting the Bala branch entrance (with the ground sill just downstream) and deteriorate the left bank. The two recorded changes on BG side in this reach want raise or lower existing assessments.

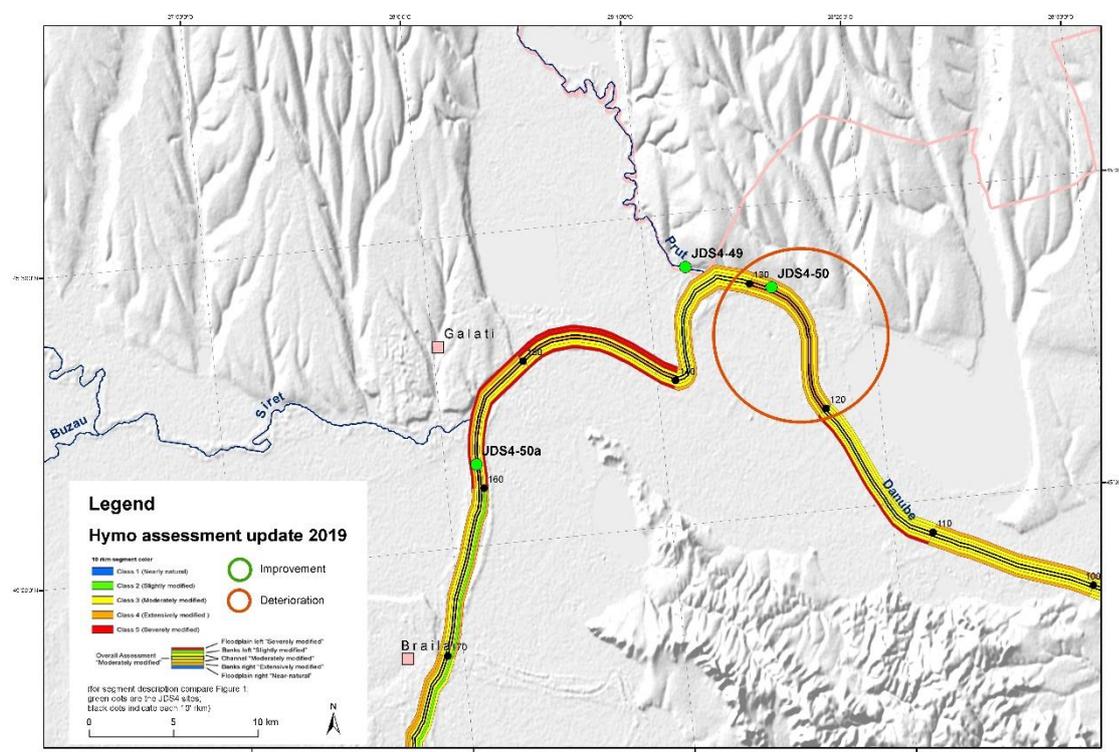
Figure 56: The expansion of Reni Sea port requires extraordinary dredging the respective segment.

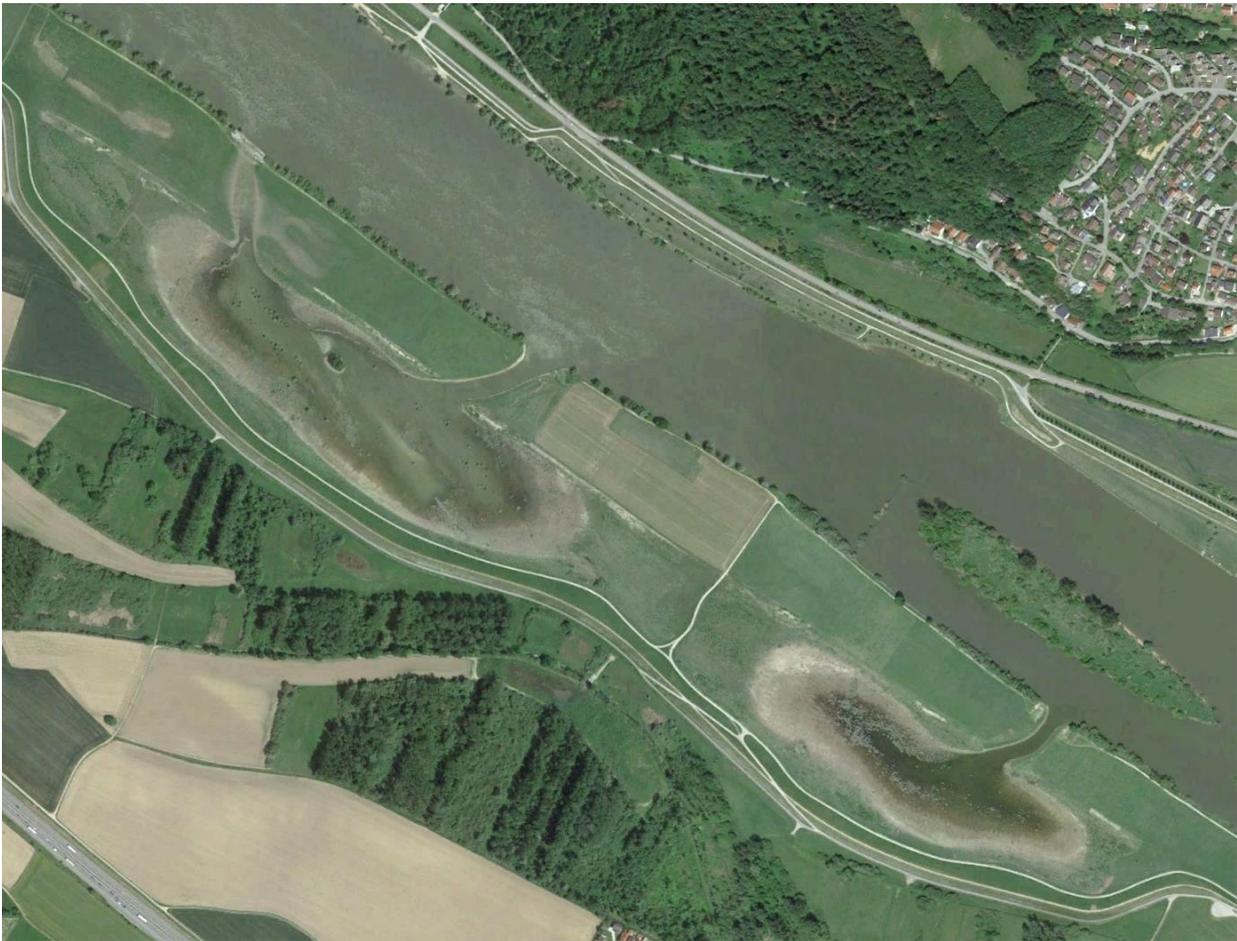
Figure 57: Floodplain restoration near Deggendorf/DE (Google Earth (2019): Satellite images worldwide. DigitalGlobe 2019. <http://www.earth.google.com>)

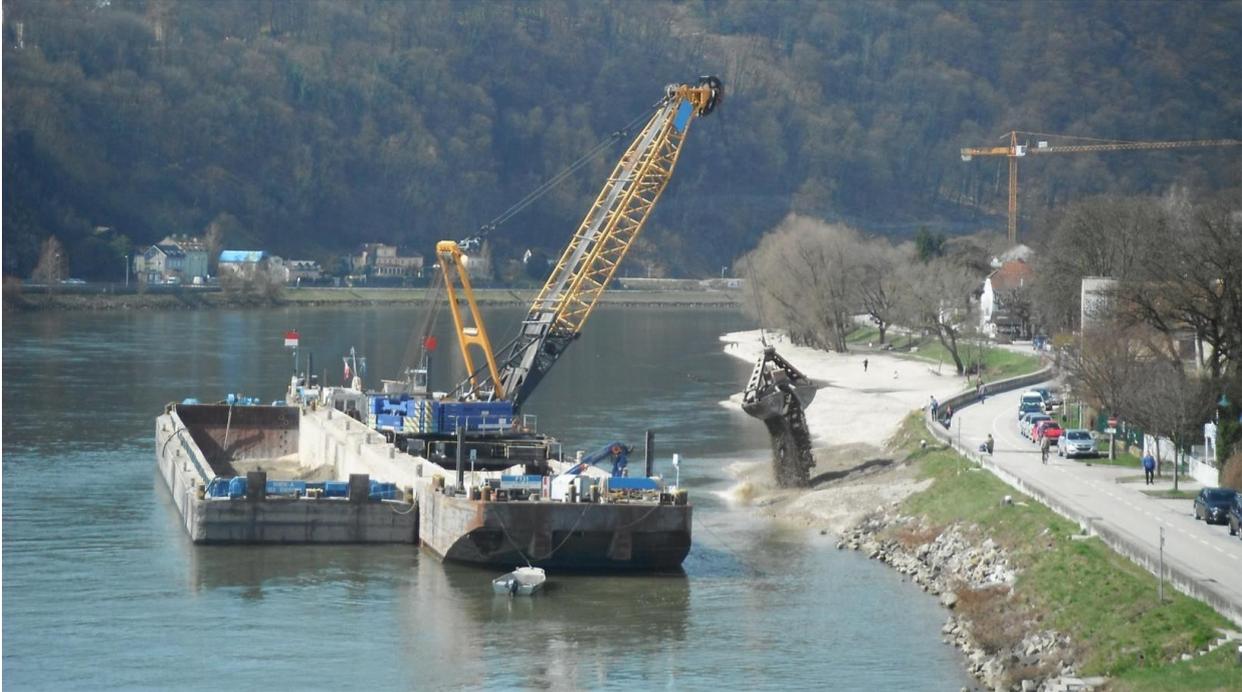
Figure 58: Bank restoration in the Wachau/AT ViaDonau

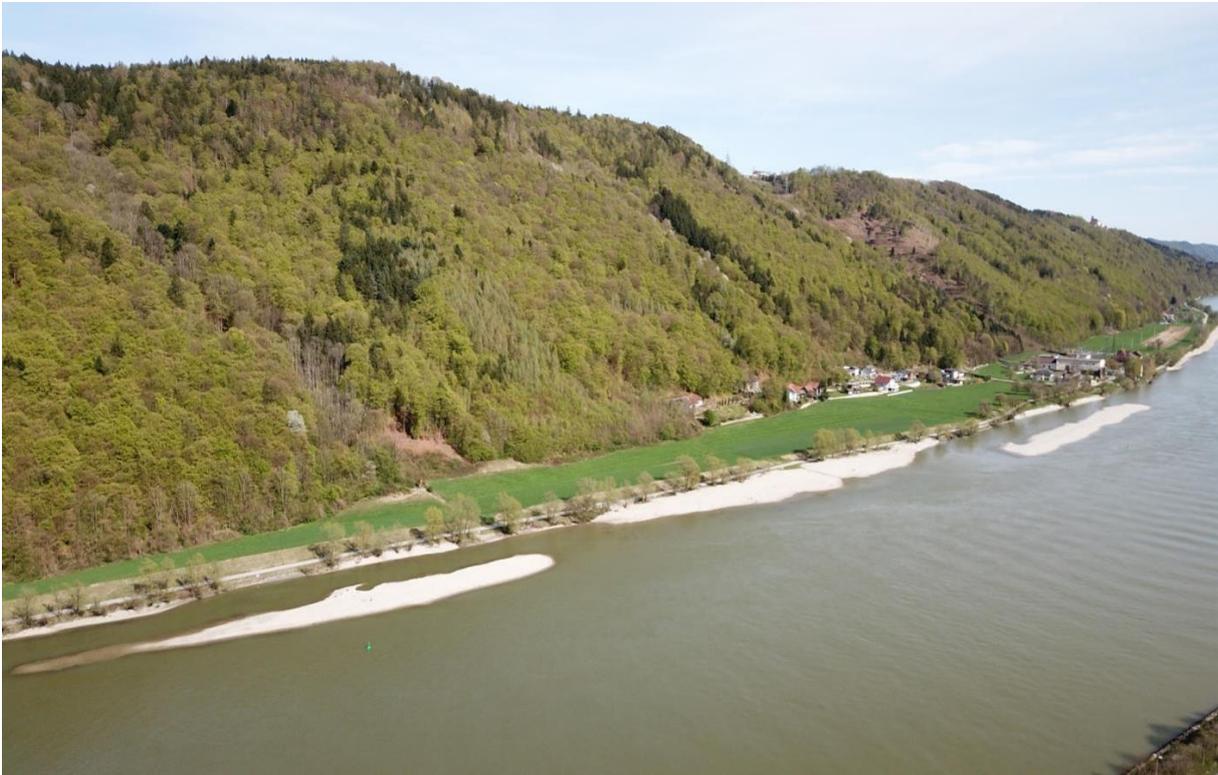
Figure59: Introduction of gravel bars in the Wachau/AT, ViaDonau

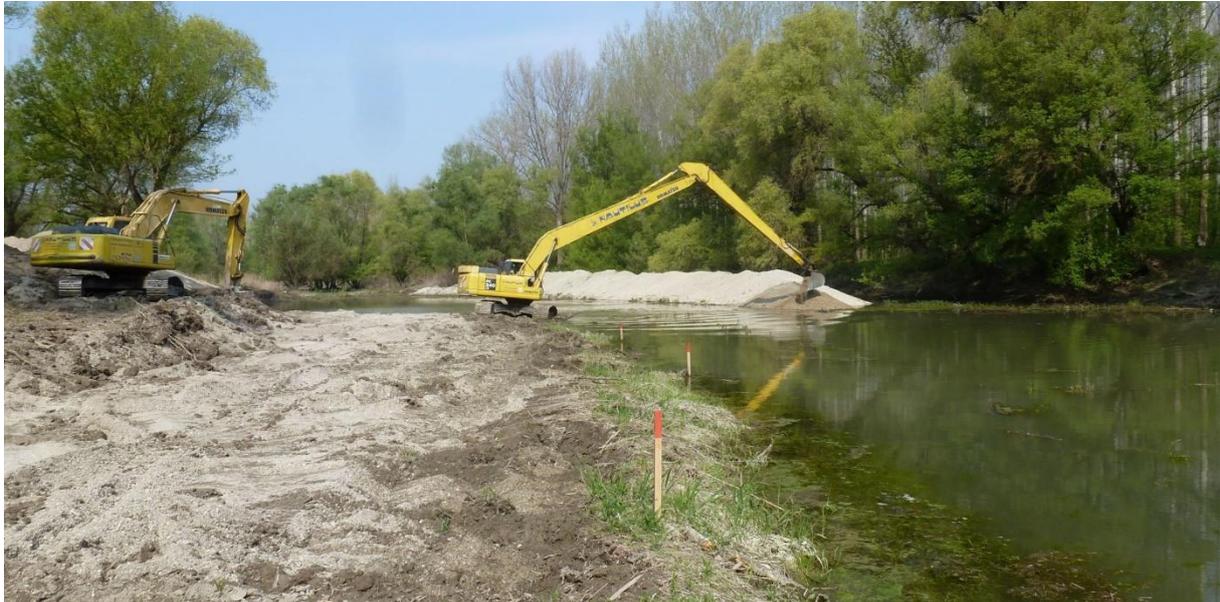
Figure 60: Restoration of side-channel connection along the Slovakian Danube <https://broz.sk/obnova-prveho-ramena-klucoveckej-ramennej-sustavy/>
